**The effect of voids on the corrosion of post-tensioning
tendons: Second destructive examination**

PPR244

PUBLISHED PROJECT REPORT

by M McKenzie (TRL Limited)

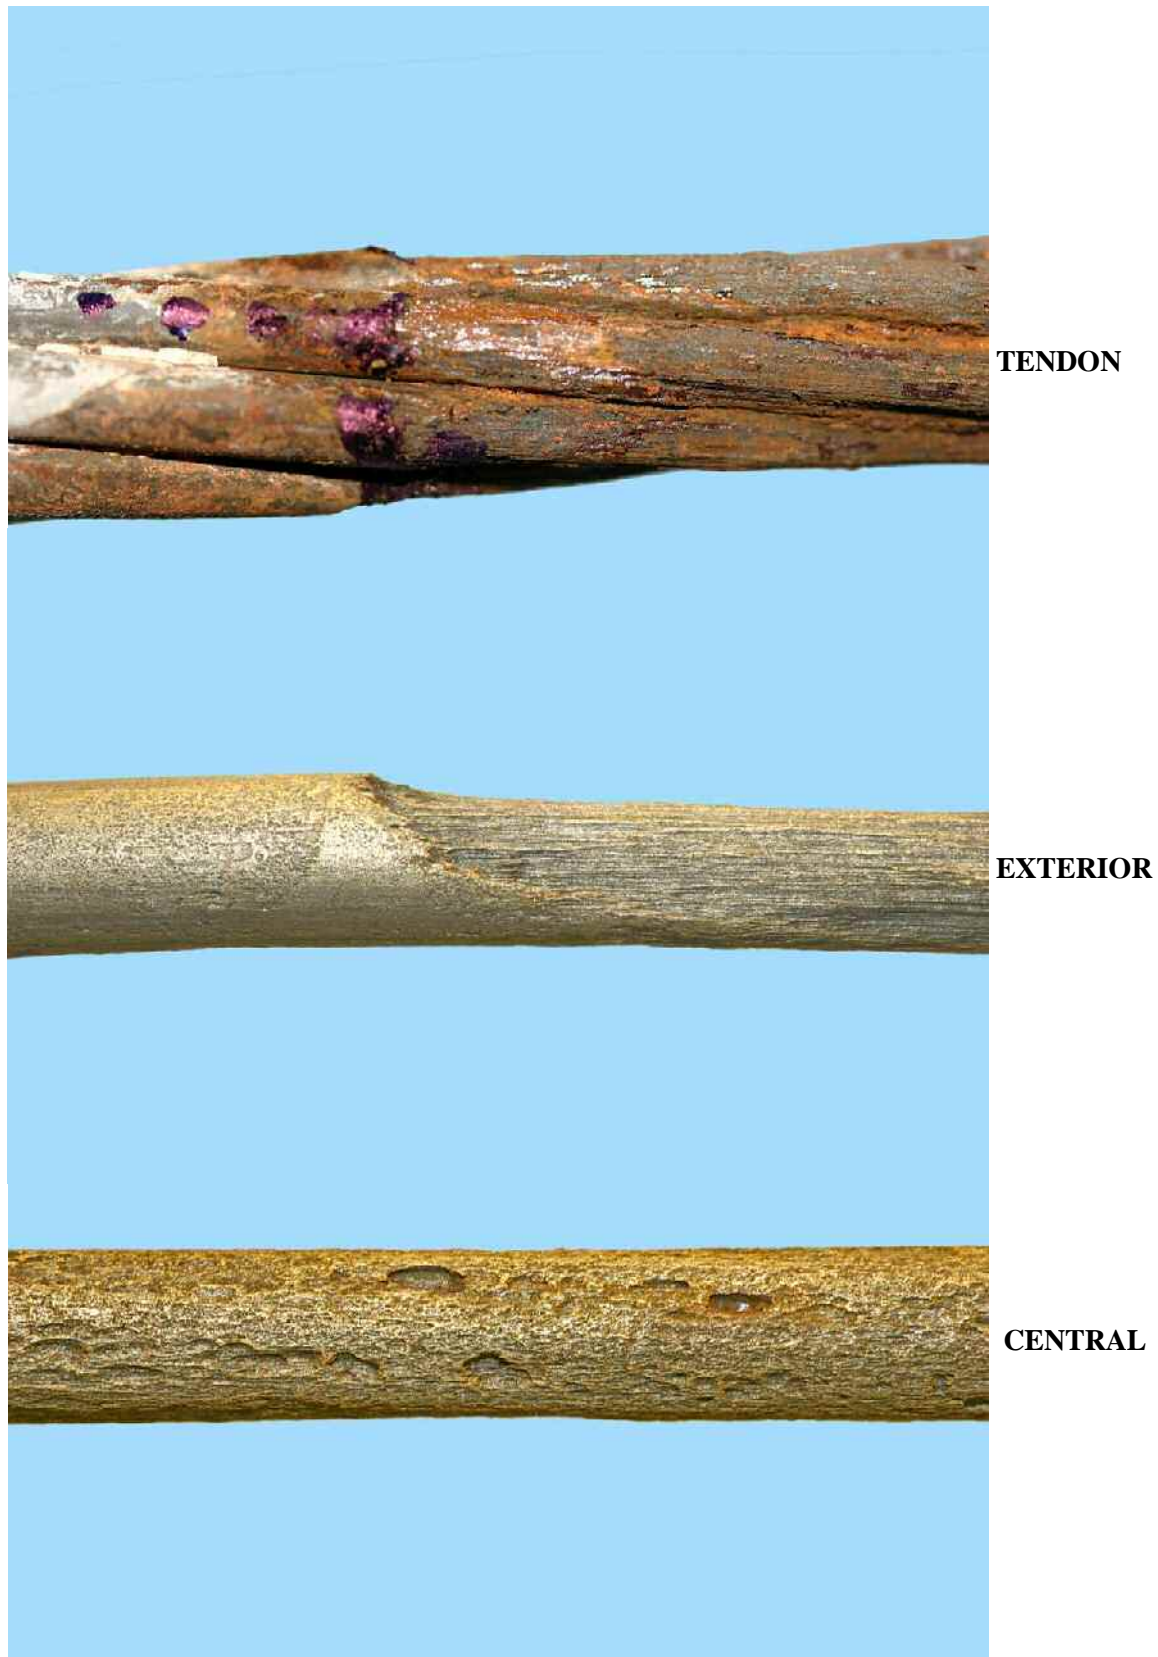
The tendon removed from the centre void segment was heavily corroded in the void zone. Loosely adherent corrosion products were relatively easily removed by wire brushing to reveal significant loss in section on all the exterior wires (Figure 10); there was little corrosion on the tendon away from the void zone. When the individual wires comprising the tendon were separated some corrosion could also be seen on the central straight wire. After derusting the loss in section on the exterior wires could be clearly seen; it was estimated that loss in cross-sectional area was around 20%. Corrosion on the central wire was limited to relatively minor pitting.

Figure 10 Appearance of rusted tendon and individual wires after three years exposure: Centre void

In the previous destructive examination of a stressed tendon (after two years exposure) the most severe corrosion was found in the segment with a bare section between two grouted sections. At that time only one wire had been affected with a maximum section loss of only 10%. After three years, loss in section in that position had increased dramatically so that all exterior wires had corroded with a loss in section of about 20% on each. It is likely that the tendon in the grouted section was providing a cathodic region which increased the corrosion in the void. The conditions in the void were quite severe and specific to this particular experiment involving varying states of immersion of the tendon in chloride solution so this could represent a relatively high rate. It would be useful to carry out further testing of this type of void under a range of immersion conditions.

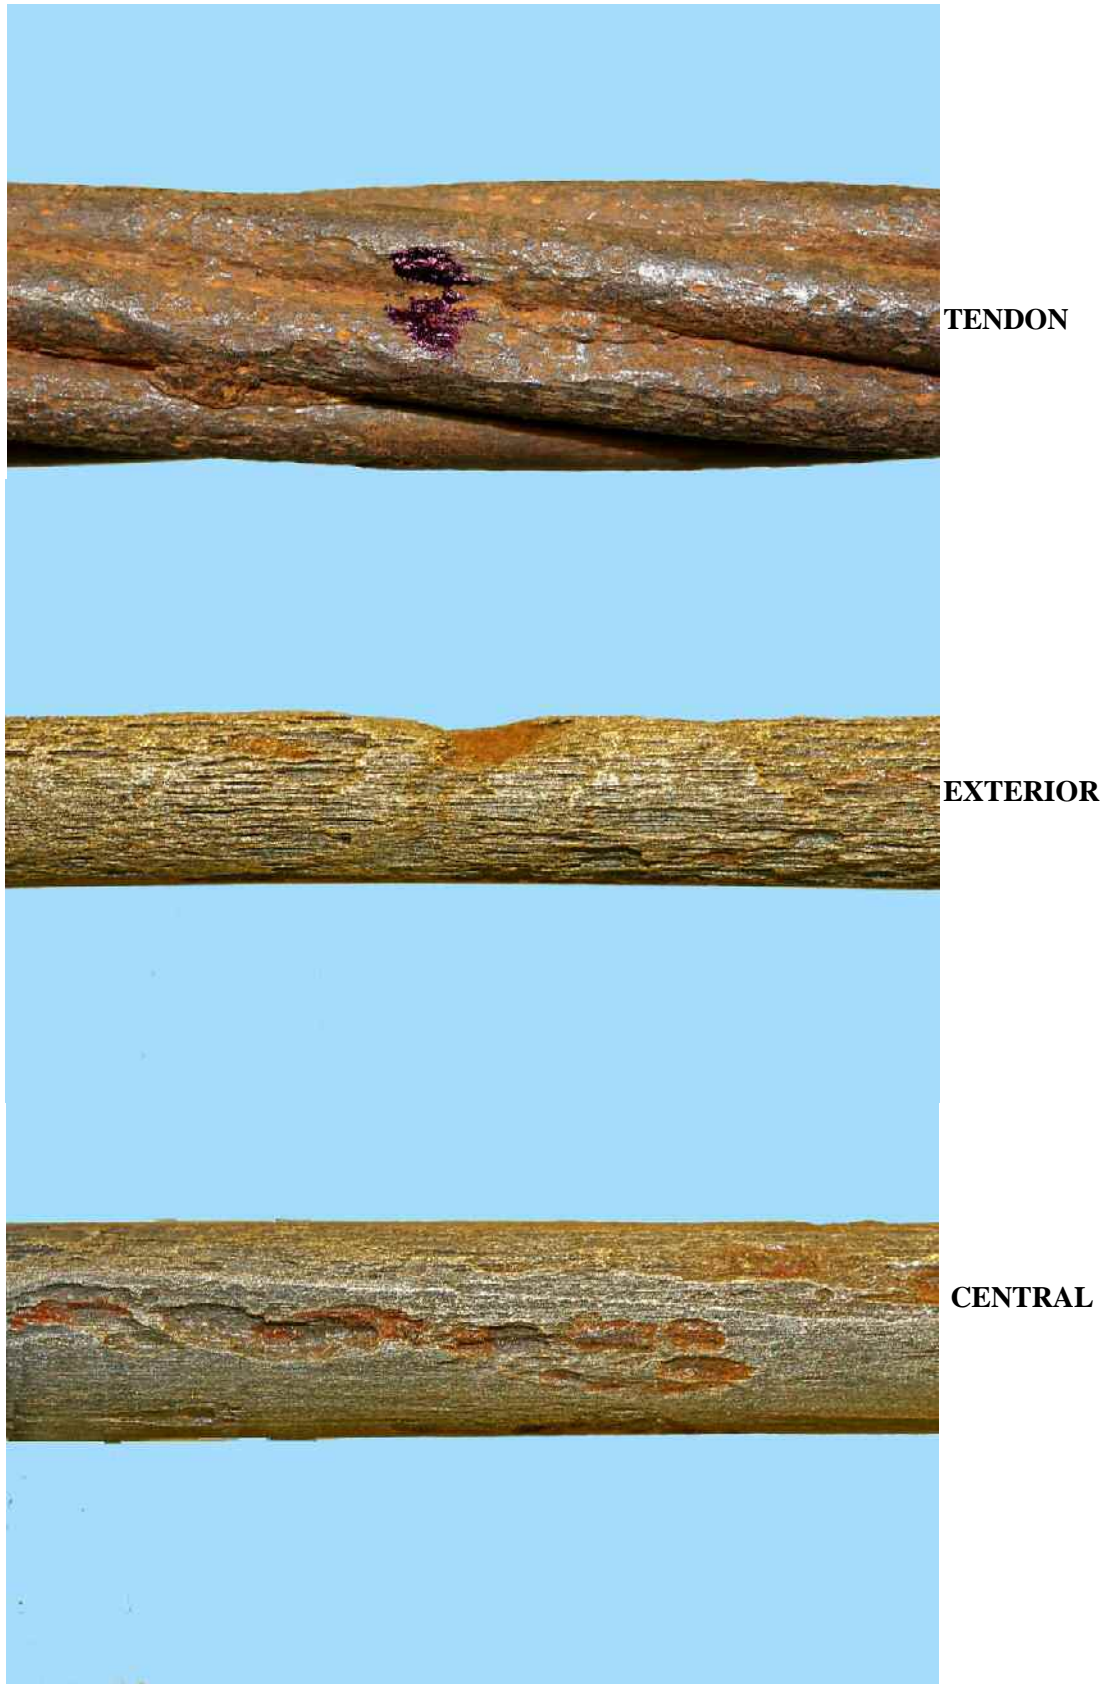
The tendon from the segment where chloride-free grout had been cast half way up the tendon was corroded along its length (Figure 11) with corrosion concentrated on the sides of the tendon (ie at the interface between the tendon and the grout). Wire brushing revealed a rough striated surface with some pitting and loss in section. After derusting one position of significant loss in section could be seen although this was much less severe than on the centre void wires. There was also some pitting on the central wire

**Figure 11 Appearance of rusted tendon and individual wires after three years exposure:
Grouted half way up tendon**

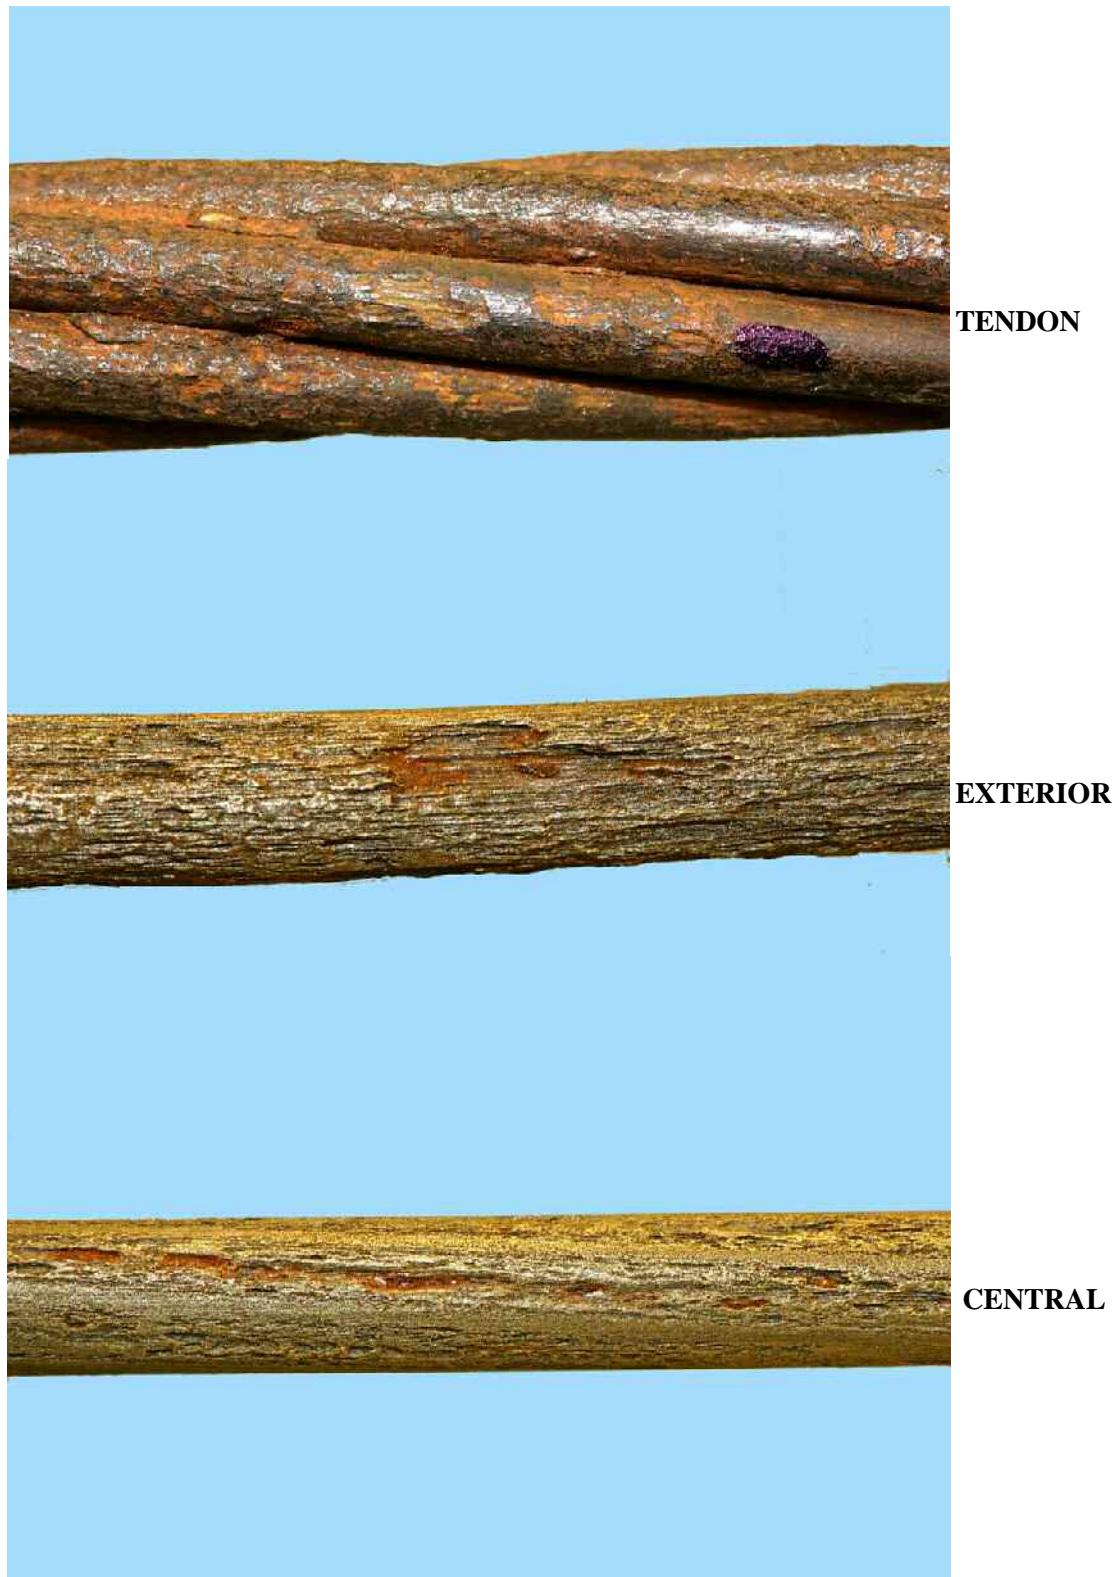
The tendon from the segment where grout containing chloride had been cast half way up the tendon was also corroded along its length (Figure 12) with corrosion concentrated on the side of the tendon that had been in contact with the grout. The condition of the individual wires was similar to the tendon with chloride free grout.

**Figure 12 Appearance of rusted tendon and individual wires after three years exposure:
Grouted half way up tendon with chloride in grout**

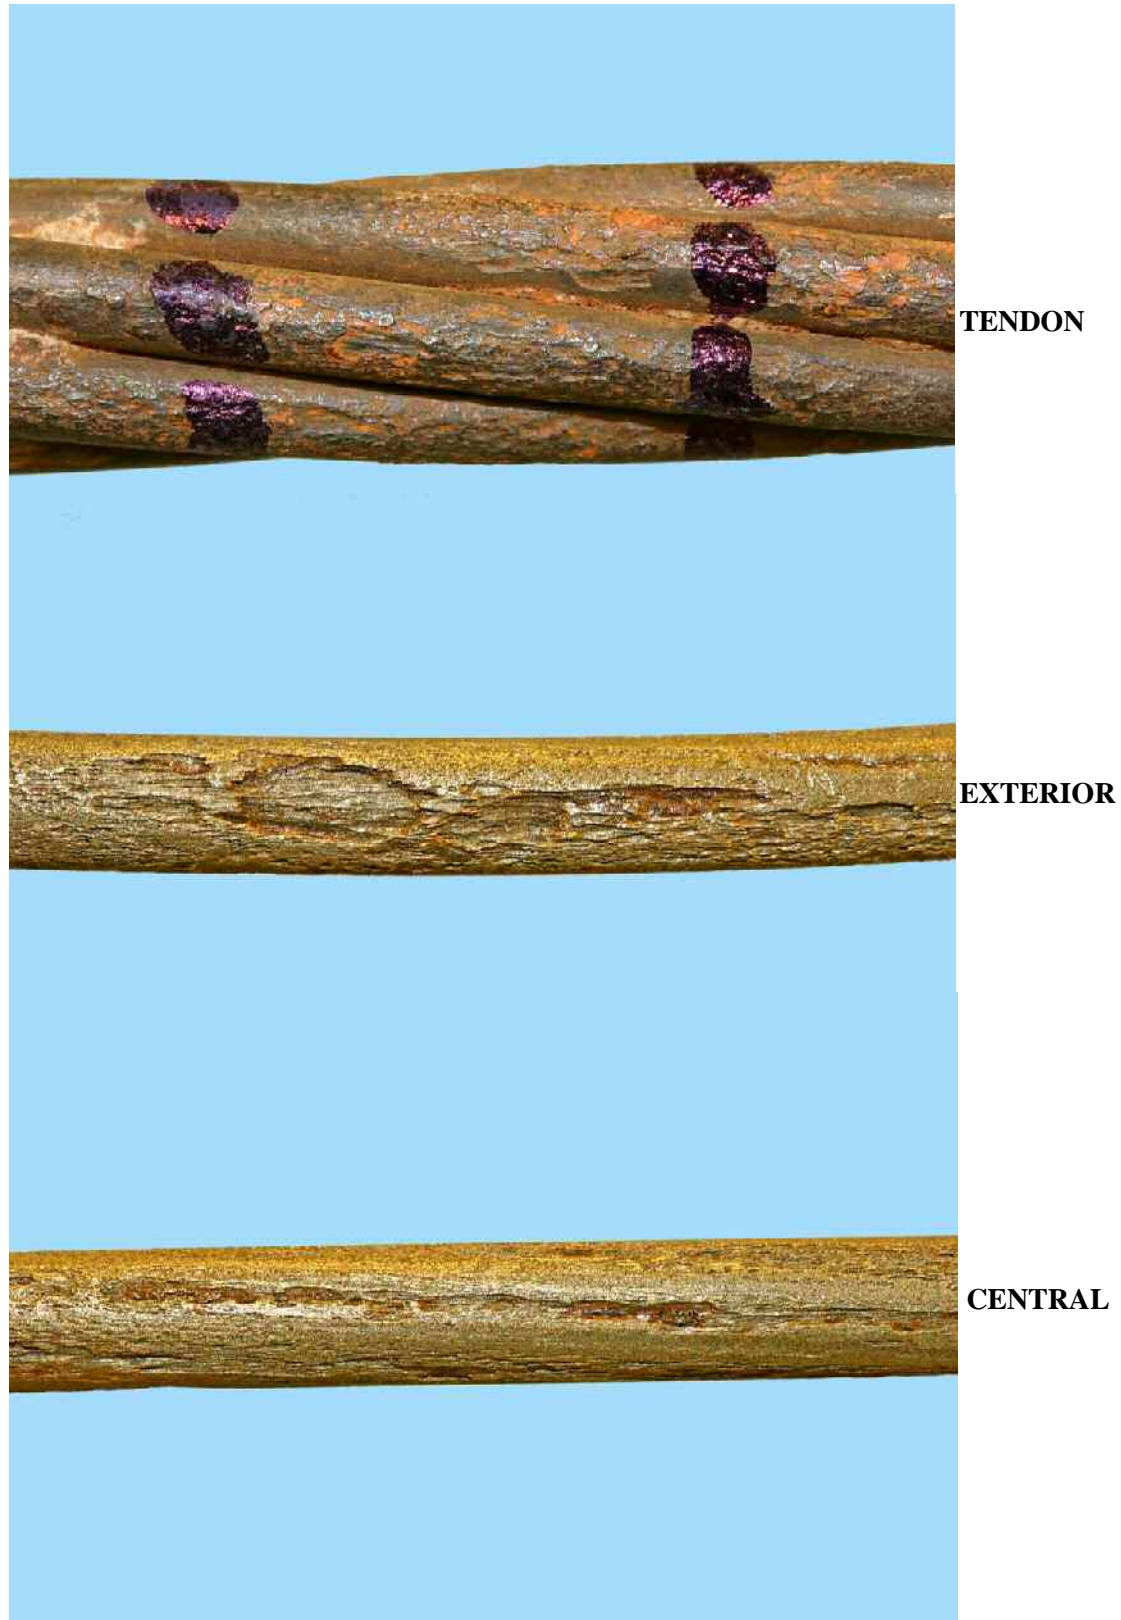
The tendon from the segment with low cover and gaps down to the steel was most corroded in the gap locations (Figure 13) but corrosion had spread beyond the gap zone. Corrosion in the gap zones was most severe on the upper side (ie the side in contact with chloride solution) but corrosion was evident in other areas as well. There were some areas of loss in section on the exterior wires but this was not as severe as in the central void specimens. There was also some pitting on the central bar.

Figure 13 Appearance of rusted tendon and individual wires after three years exposure: Low cover with gaps

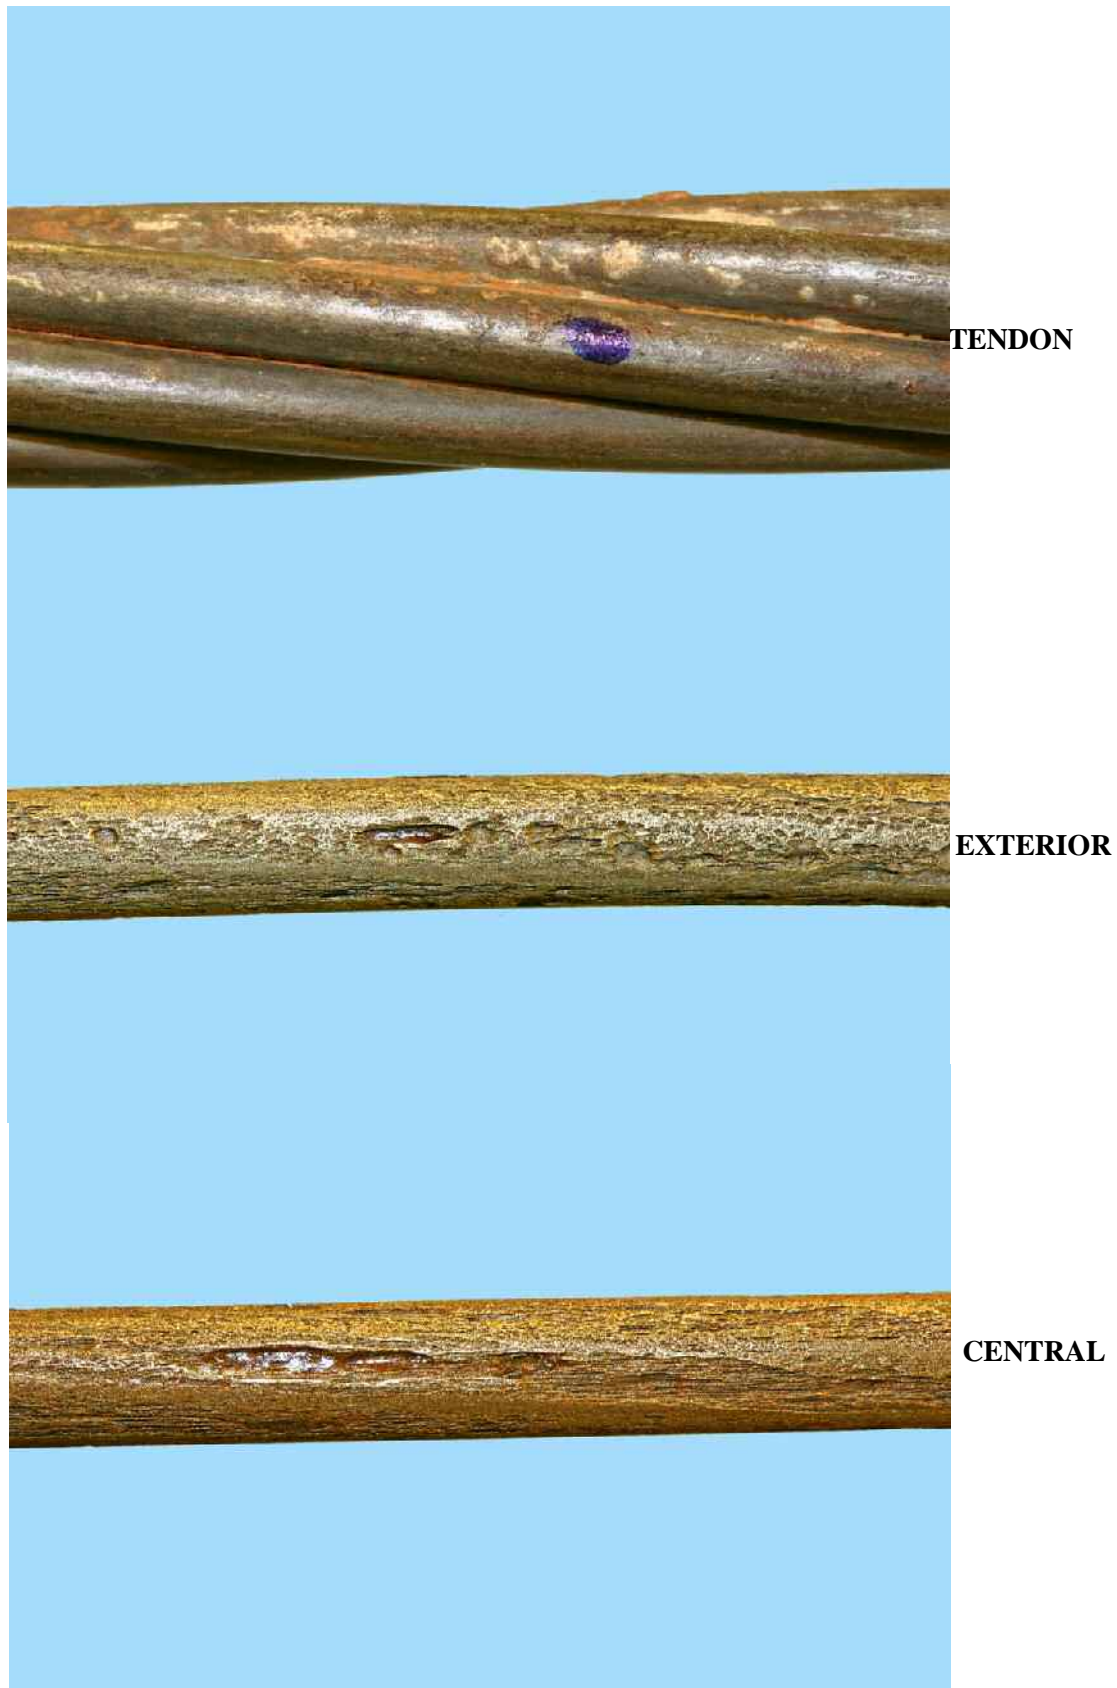
The tendon from the segment with low cover along the whole length of the tendon was the least corroded with only patches of relatively light surface rusting (Figure 14). After derusting some relatively light pitting could be seen on both the exterior and central wires and, in this case the central wire was similar to the exterior wires.

Figure 14 Appearance of rusted tendon and individual wires after three years exposure: Low cover

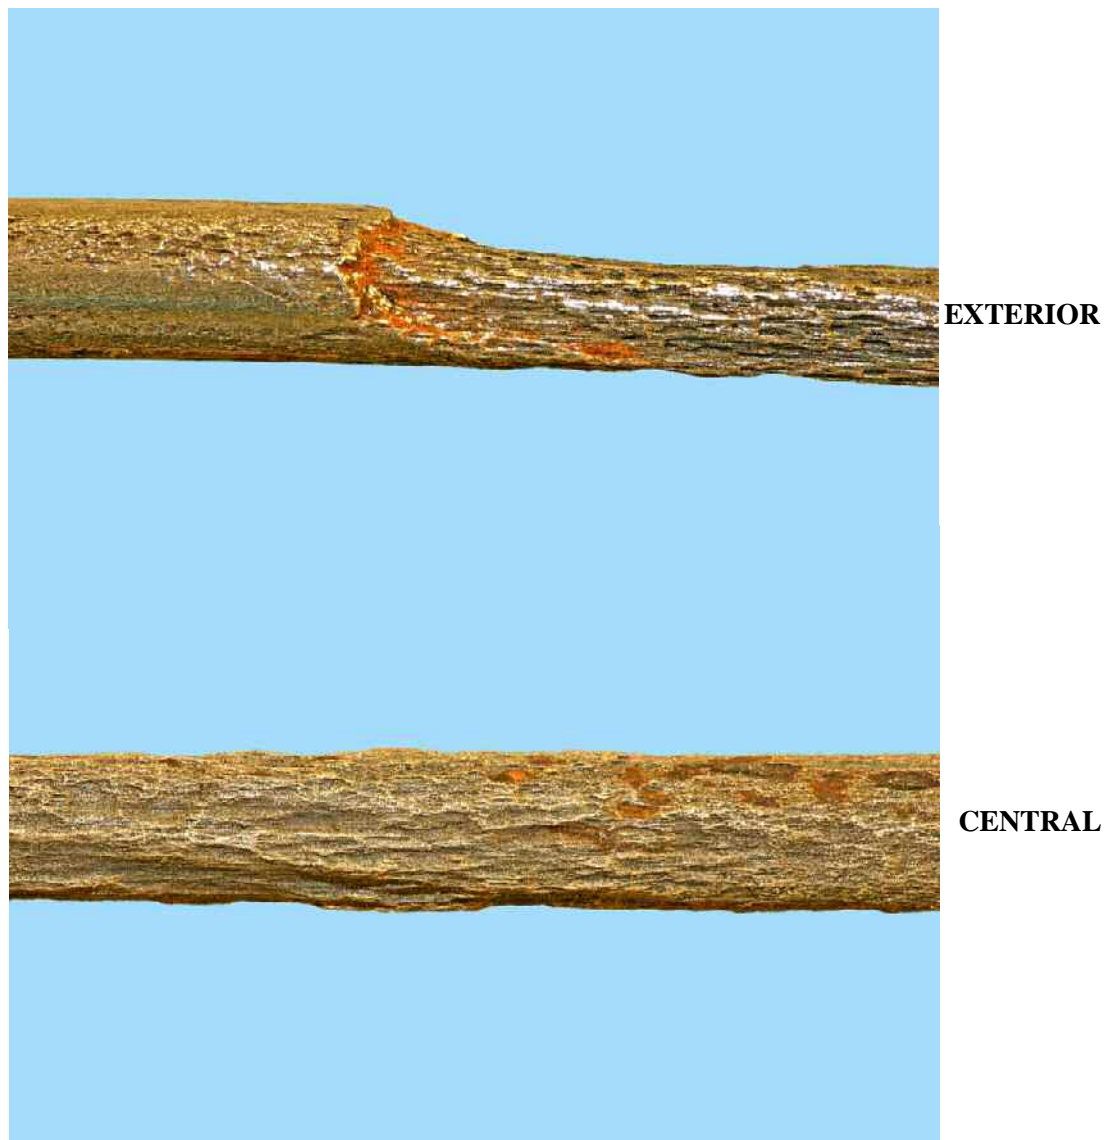
The unstressed centre void tendon (Specimen B) was similar in appearance to the stressed equivalent. There was little corrosion away from the void but there was considerable loss in section within the void. There was also some roughening of the surface and pitting on the central wire. (Figure 15).

Figure 15 Appearance of individual wires from unstressed specimens after three years exposure: Centre void

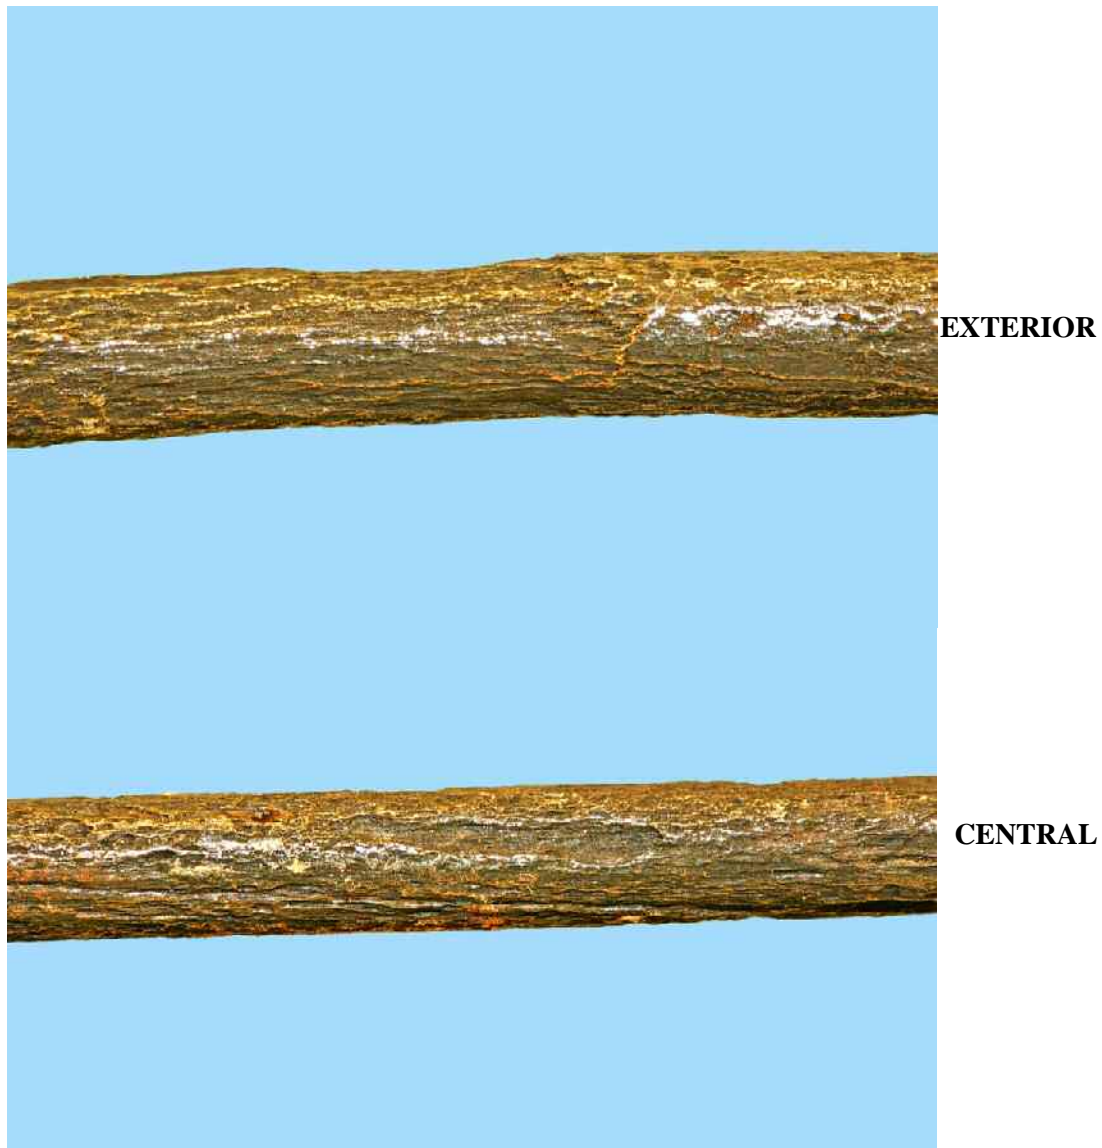
The unstressed centre void tendon (Specimen C), where chloride had been cast into the grout, was corroded mainly in the void area but the corrosion was much less severe than in specimen B. (Figure 16). There was also some corrosion away from the void area.

Figure 16 Appearance of individual wires from unstressed specimens after three years exposure: Centre void with chloride in grout

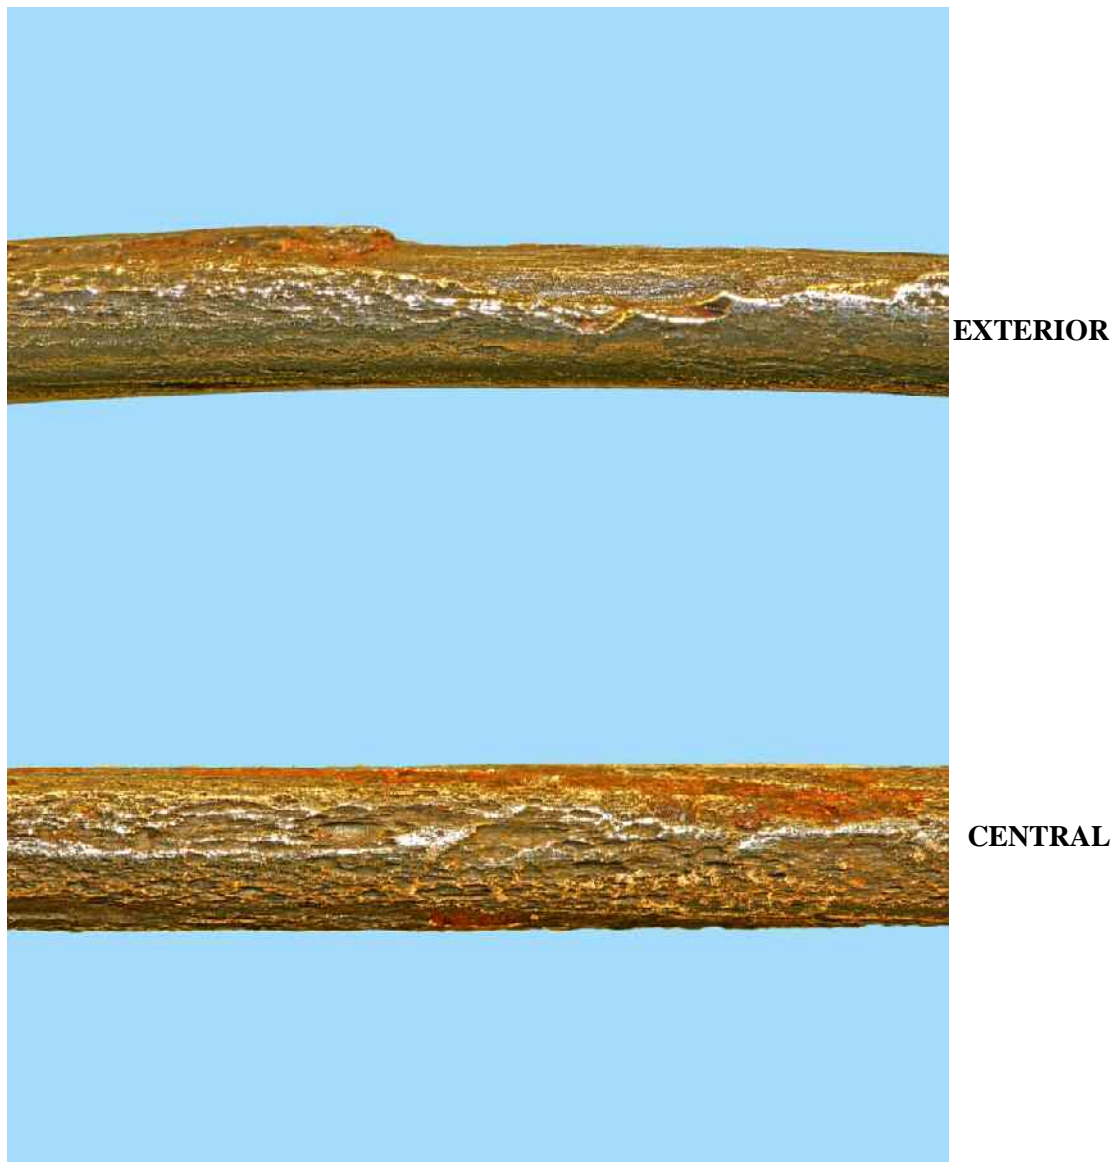
The wires in the unstressed tendon with low cover (Specimen F) had a rough surface with some significant localised loss in section on the exterior wires (Figure 17); there was also some pitting on the central wire but no significant loss in section. The grout in this specimen had cracked above the tendon. This would have allowed increased access of chloride solution to the tendon exacerbating the corrosion.

Figure 17 Appearance of individual wires from unstressed specimens after three years exposure: Low cover
