1 **A THERMAL PAVEMENT RESPONSE MODEL FOR TOP-DOWN REFLECTION**
2 **CRACKING IN COMPOSITE PAVEMENTS**

37 A Paper Prepared for Presentation and Publication,
38 at the 85th Annual Meeting of the
39 Transportation Research Board,
40 Washington, D.C.,
41 January 2006.
42
43
44
45
46
47
48
49
50
51
52

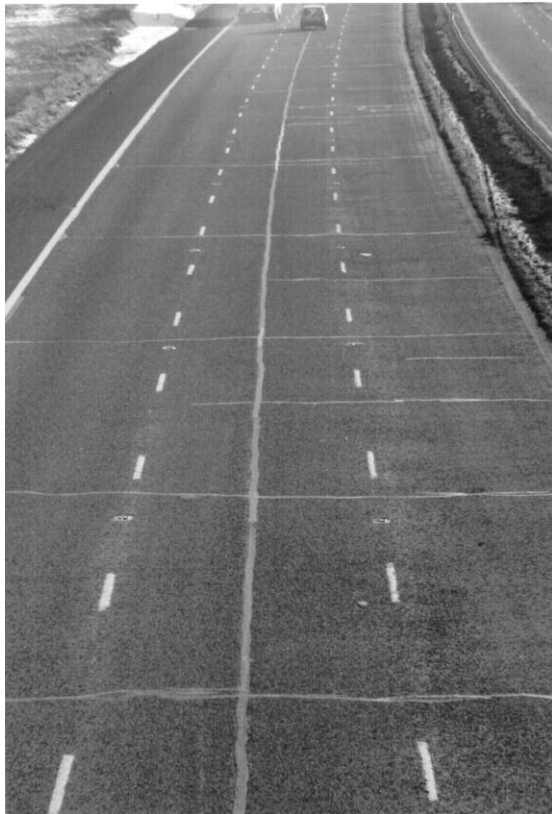
Figure 1. Reflection cracks in a typical UK composite motorway

Figure 1 is a typical example of reflection cracking in the UK. In this example, Lane 1 (which carries the majority of heavy commercial vehicles) is on the left and the lightly trafficked overtaking lane (Lane 3), in which heavy commercial traffic is prohibited, is on the right. The motorway has not received maintenance treatment since construction, 18 years earlier. The transverse reflection cracks are relatively evenly spaced and the longitudinal crack in the centre lane is a reflection crack of the longitudinal rip joint in the two concrete base slabs.

Generally the uniformity of the cracks across all the lanes suggests that traffic stresses are not the primary cause of these cracks. This is further reinforced in this example, where Lane 3 has more cracks than the heavily trafficked Lane 1. Once full-depth cracks have developed, water ingress and traffic will degrade the cracks more rapidly in the most heavily trafficked lanes. The hard shoulder in this example has not cracked but there are other examples in which the hard shoulder and not the traffic lanes have cracked. The reason being that at the time these motorways were built the hard shoulder was constructed with slurry sealed surface rather than the hot rolled asphalt surface course used for the traffic lanes and it is the characteristics of the surfacing that are crucial to the initiation of reflection cracks.

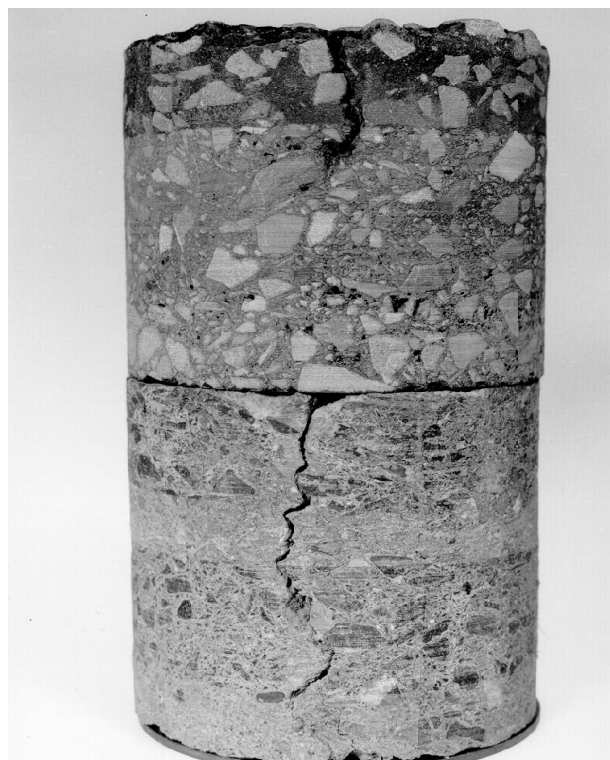
Figure 2. Core from a recently initiated reflection crack

reflection cracking. A core illustrating top-down reflection cracking is shown in Figure 2. Many other examples of top-down cracking together with the associated crack in the concrete base were observed in cores that were cut from cracks that had recently initiated or cut at the horizontal tip of a transverse crack. Examples are given in Table 1 for roads with hot rolled asphalt (HRA) surface course and HRA or dense bitumen macadam (DBM) for the other asphalt layers. In all cases the base layer was lean concrete (LC). With many of these cores the asphalt was well bonded with the cement bound base. Top-down reflection cracking was also found in asphalt overlays on jointed pavement quality concrete pavements. The investigations produced no evidence of cracks propagating upwards from cracks in the cement bound base.

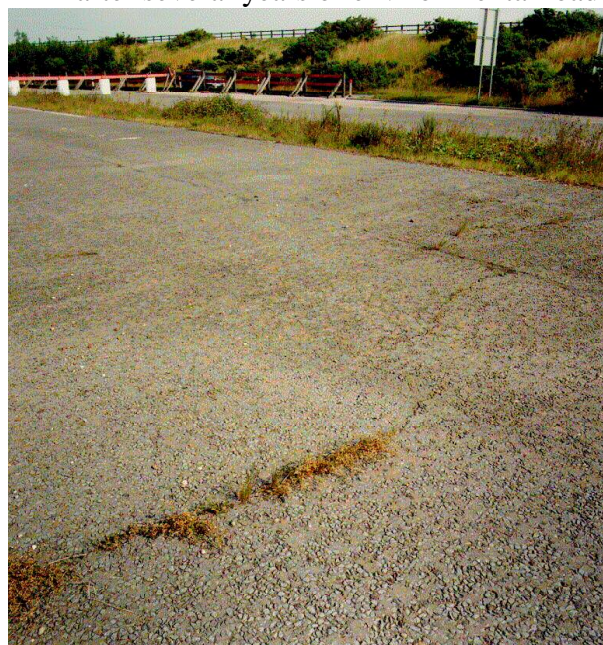
Figure 3. Reflection cracking in an untrafficked section of motorway.

The occurrence of reflection cracking in the absence of traffic is shown in Figure 3. This is an untrafficked stub-end of a UK motorway. It had been closed to traffic for over 12 years since its construction by a concrete barrier, which can be seen in the background. The

cracking pattern in this section of road was identical to that in the trafficked portion. The growth of grass in the cracks is testament to the lack of traffic.

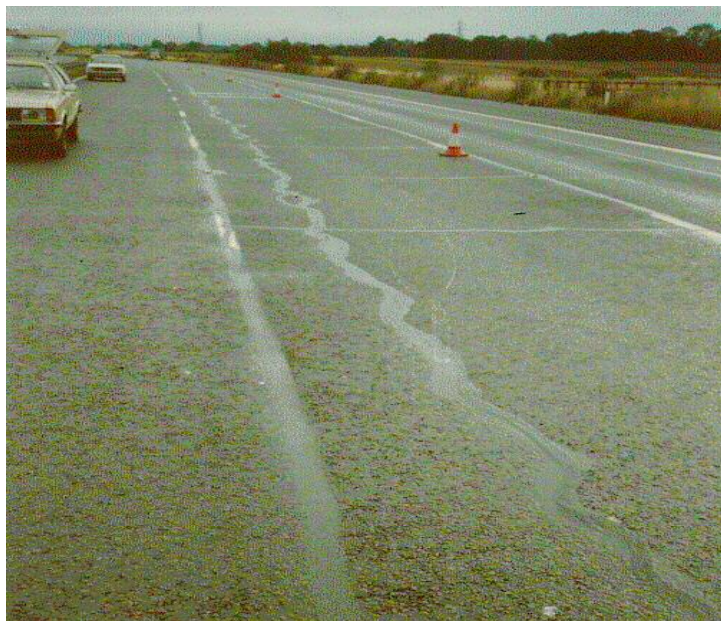
11
12
13
14
15
16
17
18
19
20
21
22
23
24
25
26
27
28
29
30
31
32
33
34
35
36
37
38
39
40
41
42
43
44
45
46
47
48
49
50
51
52
Figure 4. Reflection cracks in the centre lane of the M4 motorway

6 Figure 4 is an example of transverse reflection cracks on the M4 motorway that
7 illustrates a number of features. This road was 17 years old and consisted of 175 mm thick
8 cement bound base covered with 175 mm of asphalt. All layers consisted of the original
9 materials. The cracks have been over-banded and the longitudinal crack was a reflection
10 crack of the rip-joint between the two cement bound base slabs.

Only the centre lane (Lane 2) had reflection cracks. The heavily trafficked Lane 1 (right-hand side of Figure 3) and the lightly trafficked Lane 3, on which heavy commercial vehicles are not prohibited, were uncracked. The absence of transverse reflection cracks in Lane 1 suggested that traffic loading was not the primary cause of reflection cracking.

Cores were cut from the full depth of the pavement to obtain more information about the materials and the cracks. Cores that were cut from Lane 1 and Lane 3 in line with the transverse cracks, intersected cracks in the underlying concrete base. Cracks in the asphalt that were in the process of propagating upwards from the cracks in the cement bound base were not detected. Cores cut on cracks that had recently appeared on the surface had cracks similar to those illustrated in the core shown in Figure 2. Sets of cores were also taken along the same transverse line from Lanes 1, 2 and 3 to analyse the properties of the recovered binder from the three lanes. The results showed that the properties of the bitumen recovered from the lower asphalt layers from all three lanes were similar. However, large differences were revealed in the properties of the binder from the Hot Rolled Asphalt (HRA) surface course. The penetration of the binders recovered from lanes 1 and 3 were 41 and 38 respectively and that from Lane 2 was 22. The harder binder in the surface course of lane 2, that was the result of ageing, was considered to be the reason for the reflection cracking in

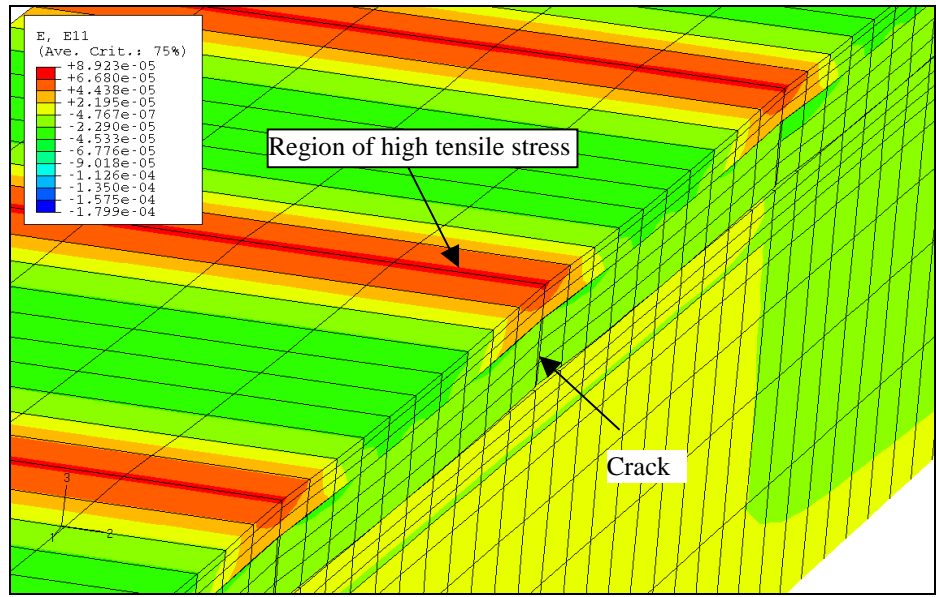
Figure 6. Detail of pavement curling

A 3-dimensional finite element analysis was performed using four thicknesses of the asphalt layer; 90mm, 130mm, 170mm and 210mm. The model simulated flexible composite pavements that were subjected to thermal cooling. This resulted in curling of the concrete slabs and separation of the sub-base when the temperature decreases with depth. Figure 6 shows that the maximum thermal tensile stress occurs at the top of the asphalt layer directly above the crack in the concrete base. The stress ratio between the tensile stress at the surface and at the bottom of the asphalt layer varied from 1.4 for 90 mm of asphalt to 7.5 for the thickest asphalt layer.

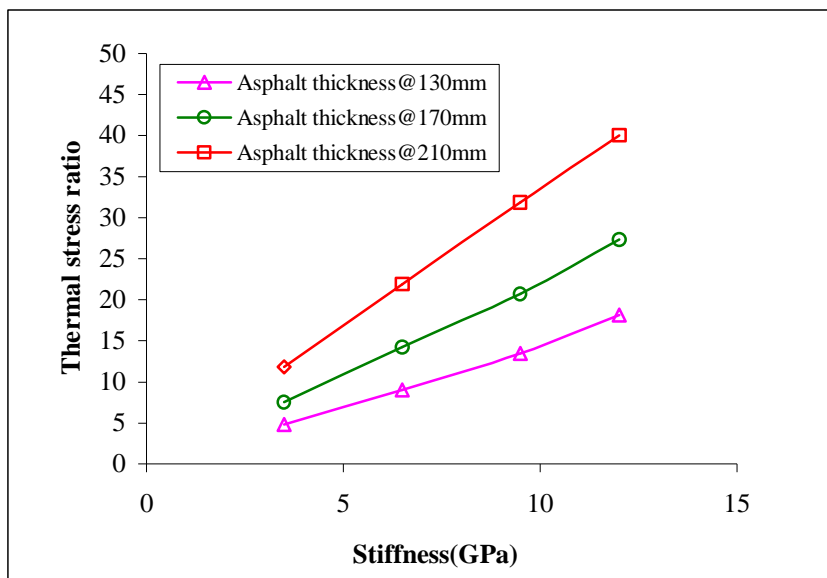
Fig. 8. Effect of increase in the surface course stiffness as the result of ageing on the thermal stress ratio

The effect of ageing was investigated by increasing the stiffness of the top 40mm of the asphalt layer from 3.5 GPa to 12 GPa. This had little effect on the maximum thermal tensile stress at the bottom of the asphalt layer. On the other hand, the ratio of the thermal tensile stress at the top to that at the bottom of the asphalt layer, shown in Figure 8 as a function of the stiffness of the surfacing and thickness of asphalt, indicates that the thermal stress will increase almost linearly as the asphalt becomes stiffer as the result of ageing. Ageing will also reduce the relaxation characteristics of asphalt and its ability to accommodate restrained tensile strain. This suggests that, with age hardening, the tensile stress at the surface will grow with time. At the same time the asphalt will have reduced capacity to withstand this tensile stress and that the onset of reflection cracking will occur when the asphalt ages to an extent that it is no longer ductile enough to withstand the thermally induced tensile condition.
