Automated inspection of highway structures

Stage 3

PPR 338

by S McRobbie (TRL)

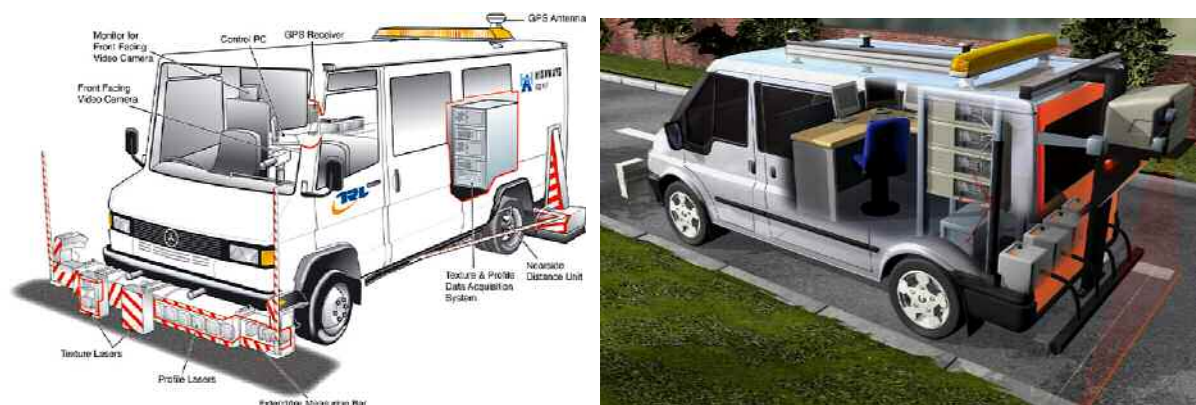
Figure 1: HARRIS1 and HARRIS2 vehicles, developed and operated by TRL on behalf of the Highways Agency.

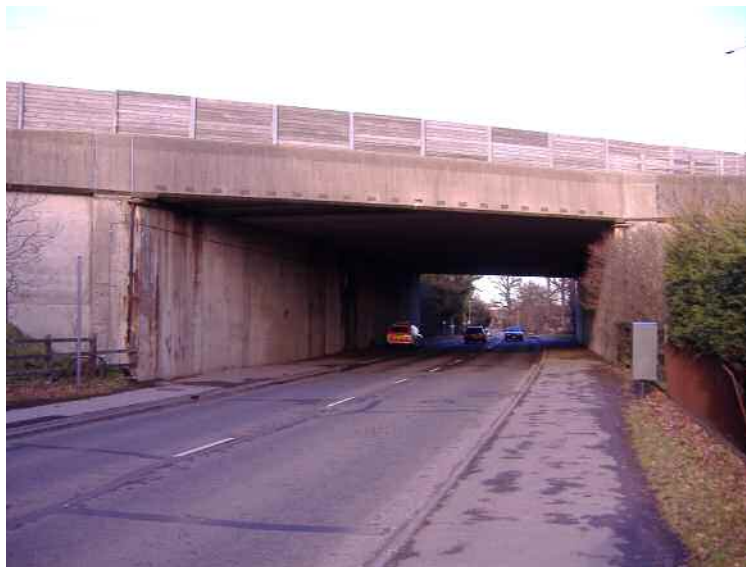
Figure 3: Winnersh site M4 over B3030 – southern view.

The bridge was of beam and slab construction with a width of 33.8m, and a span of 12.9m. The headroom under the structure was 5.05m. The bridge comprised precast post-tensioned beams (PSC), an in situ concrete slab, reinforced concrete cantilever abutments, and spread footings.

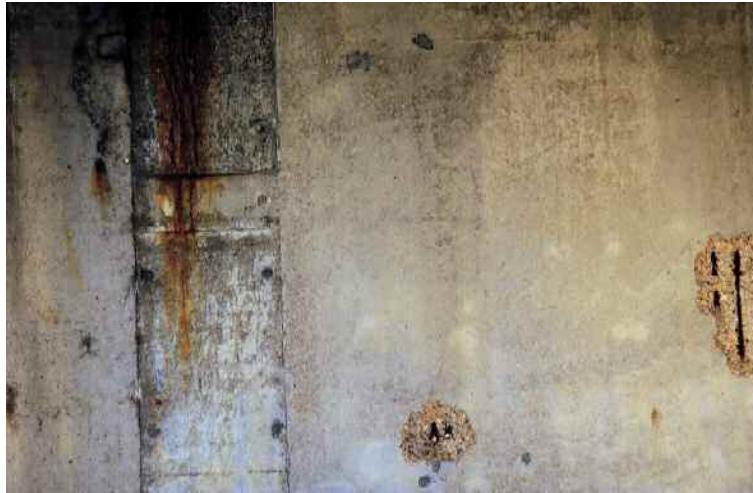
Figure 4: Original image of part of structure.

Reference data was collected in order to assess the performance of the various segmentation methods tested. To produce the reference data each image (such as the one shown in Figure 4) had an array of 200mm grid squares overlaid on it. The images were then examined by an inspector who used software to record the locations (as shown in Figure 5) of any one of a range of defects (a list of recorded defects is given in Appendix B). Red cells in Figure 5 are those deemed to contain defects or features, orange cells contain other markings.

Figure 11 shows the results of the entropy-based segmentation process on the same portion of structure shown in Figure 4. Figure 12 shows the results of the wavelet based segmentation method. The red and orange blocks show the reference data categorisation of each image cell: red areas have been deemed to contain defects or features in the reference data; orange areas contain marks which may confuse the segmentation processes.

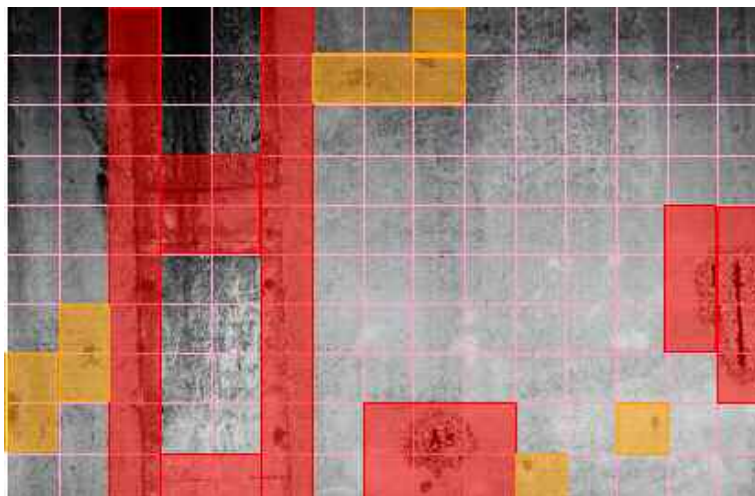
Figure 5: Reference data showing grid squares where features were noted by inspector, overlaid on image.

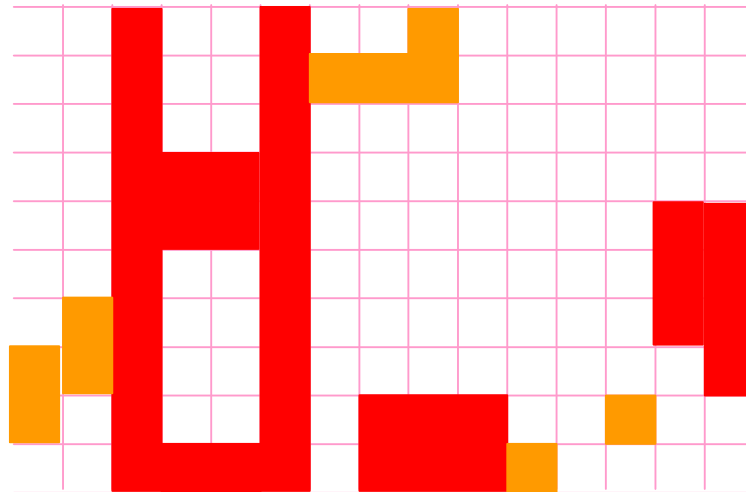
Figure 6: Reference data showing grid squares where features were noted by inspector.

This output feature map (Figure 6) was then kept for comparison against the automated segmented output. To assess the performance of the segmentation, the segmentation process was applied to each of the images in turn, and the output was compared, both visually and quantitatively, with the reference data for the same image.

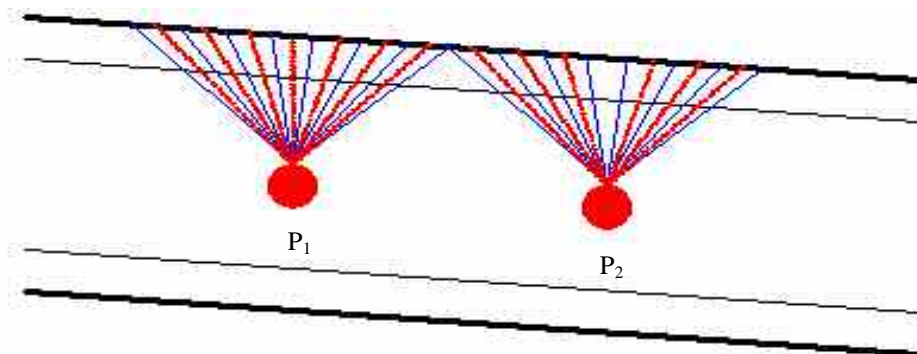
Figure 7: Illustration of enhanced multiple position.

In the enhanced multiple position approach (shown in Figure 7) the camera is set up at a location (P_1), from which a number of images are taken at defined camera bearings and elevations. Laser measurements are taken to record the distance from the camera to the structure. The camera is then moved to a second location (P_2) and more images are taken. This process is followed until the entire structure has been imaged. The bearings, elevations and distances are then used to reproject the images as if they had been taken perpendicularly to the structure surface.

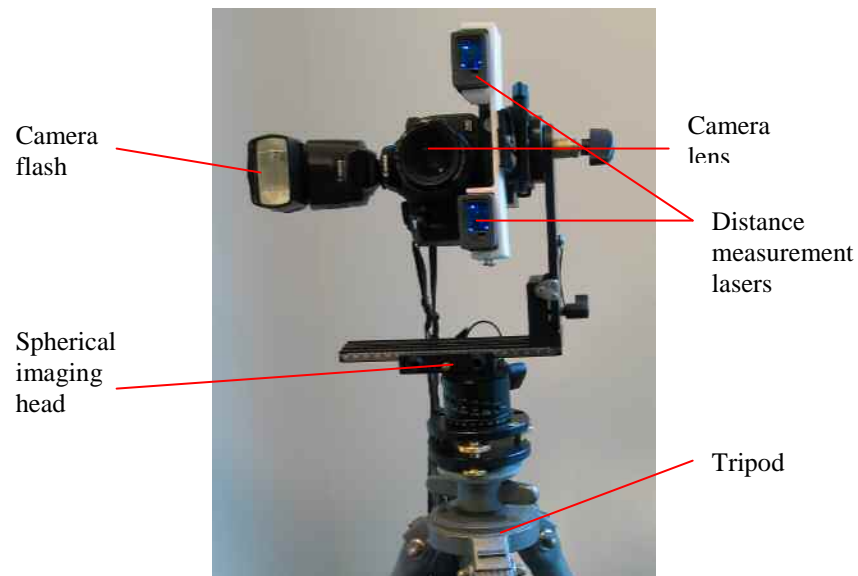
Figure 8: Prototype image collection system used in work

Figure 8 shows the imaging head used to collect images for this research. The image shows a camera mounted on a spherical imaging head, on a tripod, which is set to enable the focal point of the lens to remain in the same location in space even when the camera is rotated or elevated. Also visible are the twin distance measurement lasers (above and below the lens) used to ensure accurate camera – structure distance recording, and the flash used to minimise lighting variability.

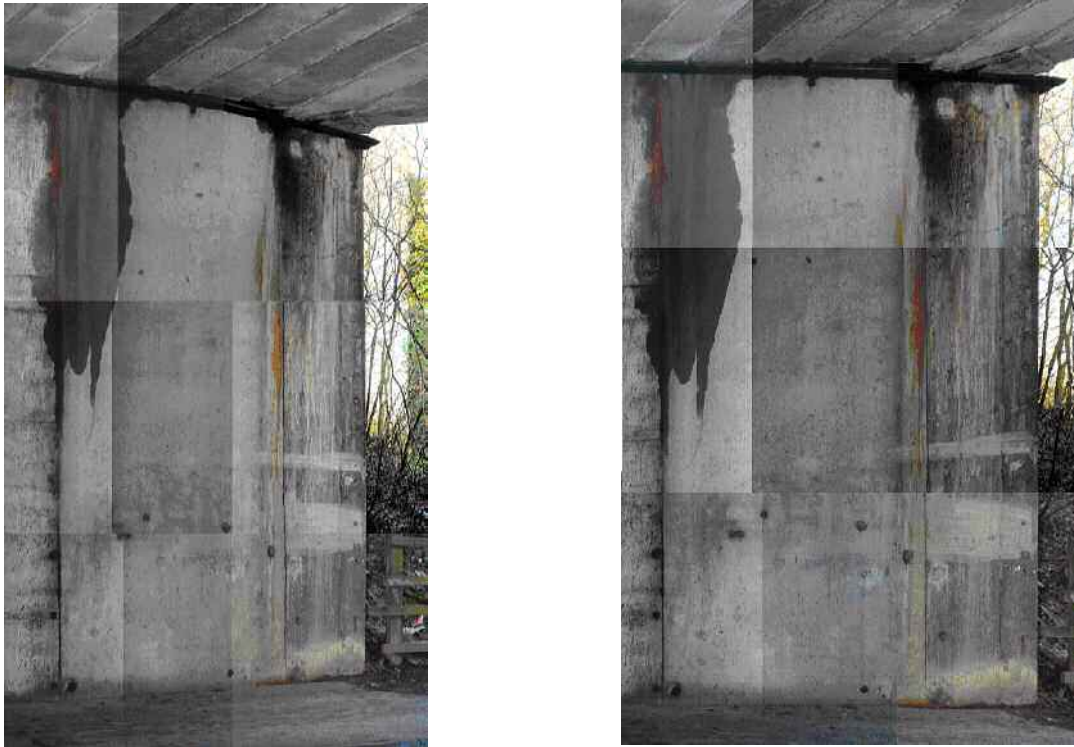
Figure 9: Example of images collected on site (left) and reprojected to appear perpendicular (right).

By making use of the imaging position data (bearing and elevation) for each image it is possible to mathematically resample the image data and reproject it to display the image as it would have looked had it been taken perpendicularly to the surface of the structure (Figure 9).

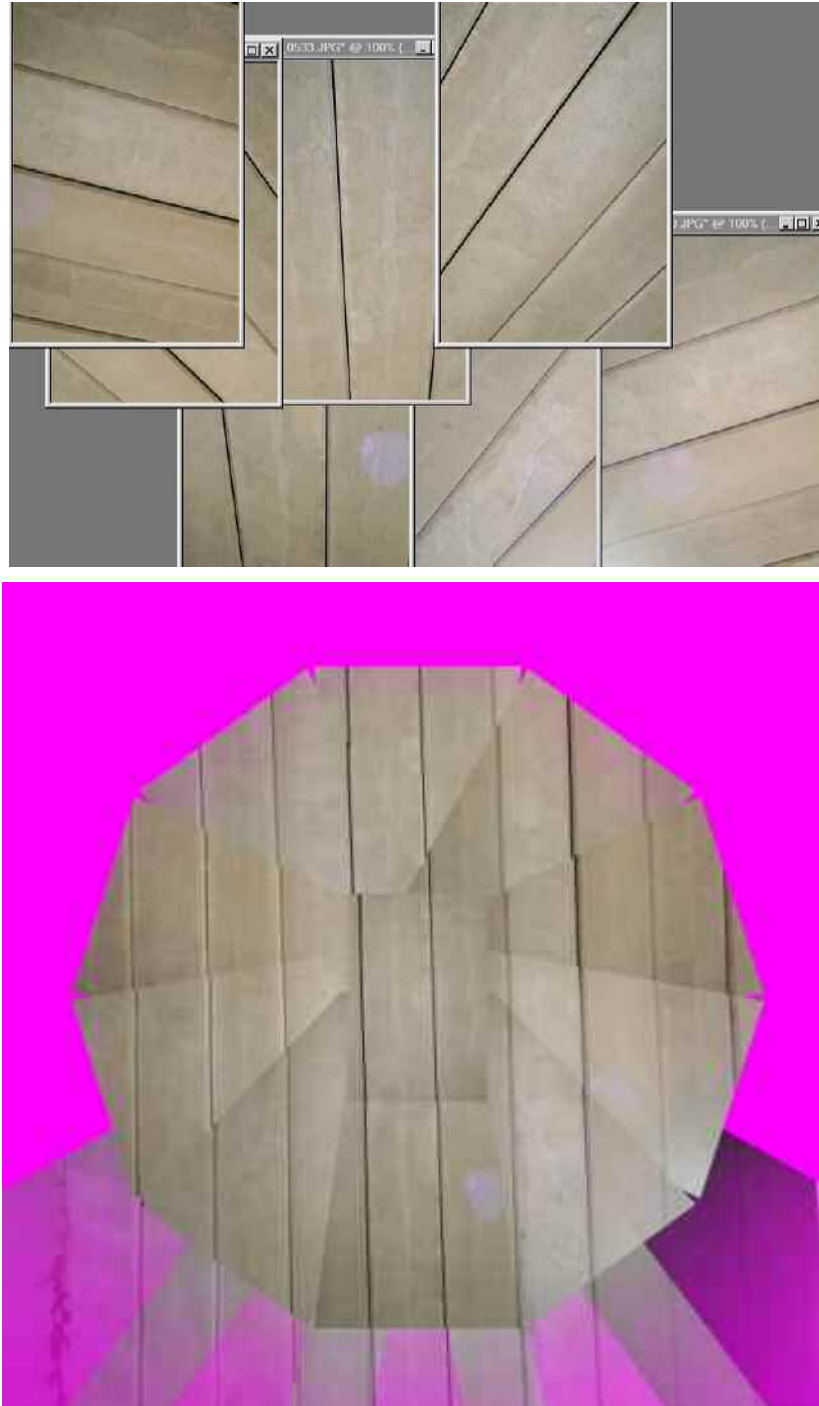
Figure 10: Example of soffit images collected on site (top) and reprojected to appear perpendicular (bottom).

This produces images which are much easier for a human to look at and interpret as they are not full of discontinuities and misalignments. This is especially worthwhile on soffits as shown below in Figure 10. The top part of Figure 10 shows an illustration of problems encountered when lining up soffit images which have not been reprojected. As can be seen this gives very poor results. The same image data has been used, following reprojection, to produce the aligned image shown in the bottom part of Figure 10. This is much easier to work with and interpret.

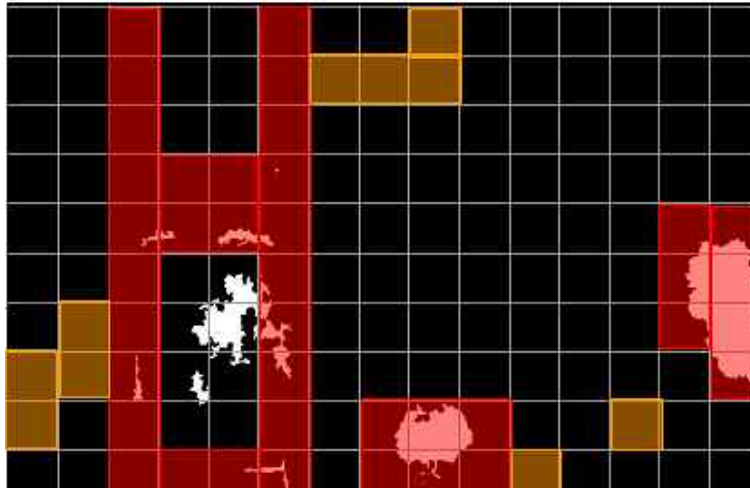
Figure 11: Reference data and objects segmented using entropy based approach.

As shown in Figure 11 and Figure 12 neither approach gave perfect results (both missed some of the reference features, and gave a few false positives, but the two approaches picked up the major features very successfully. More detailed segmentation performance assessments are given in Section 5.1.1.

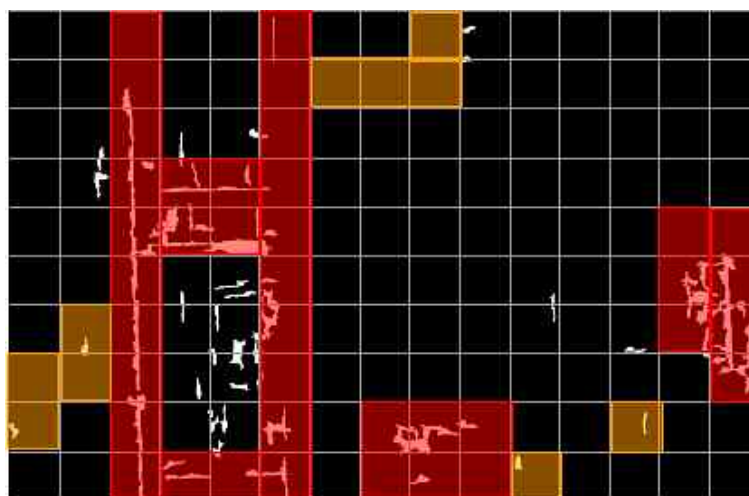
Figure 12: Reference data and objects segmented using wavelet based approach.

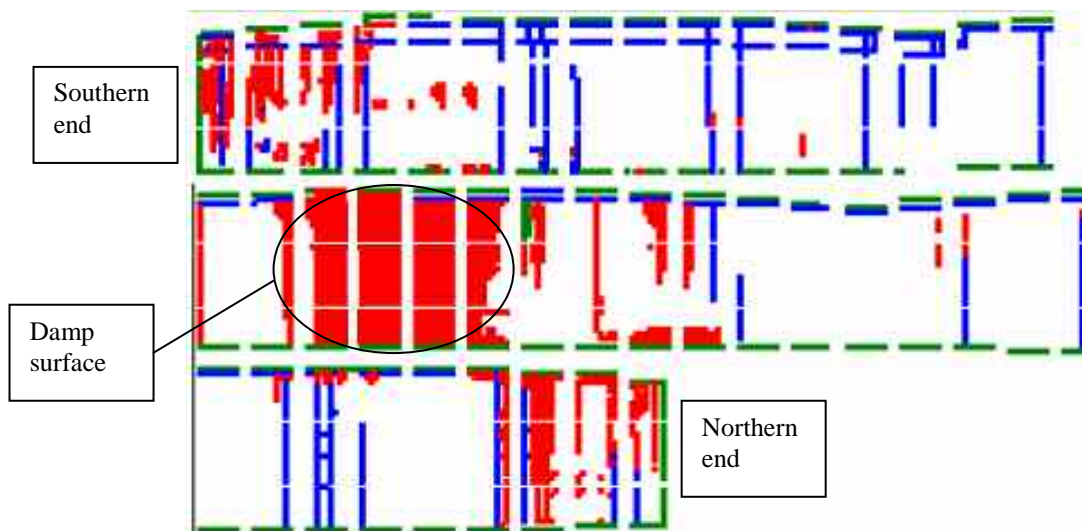
Figure 13: Reference data – western abutment of Winnersh bridge.

Figure 13 shows the reference data for the western abutment of the Winnersh bridge. The reference data has been grouped into three categories for ease of display – red shows defects, blue shows features, and green indicates 'other'. This data can be compared visually against the results of the segmentation process to see how well the segmentation is performed.

The data is split into three parts for ease of display. The top part of Figure 13 shows the first 40m of images starting from the southern end of the abutment and working north. This part of the bridge shows the presence of some defects, particularly at the southern end. A lighting cable runs along the top part of this portion of the structure, and can be seen in the reference data. The middle part is the next 40m of images, and includes a large area which was deemed damp by the inspector. The final part is the remainder of the surface, to the northern end of the abutment. The northern end of the abutment exhibits a number of defects, as did the southern end. A series of construction joints are seen throughout the reference data.

Note that the physical length of the abutment was approximately 35m, but the large amounts of overlap in each image have resulted in almost 100m of images.

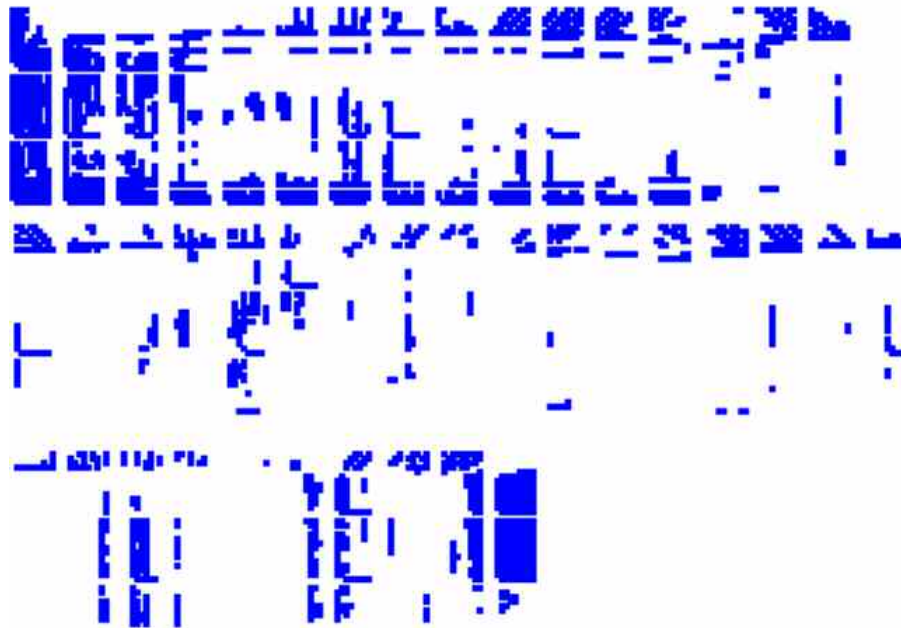
Figure 14: Areas of structure segmented by image entropy-based segmentation method – west internal abutment of Winnersh bridge.

Figure 14 shows the areas of the structure segmented using the method based on image entropy. This correctly picks up the defects at the southern end of the surface (left end of top part of Figure 14), and some of the other defects and features, but misses a lot of the damp surface reported in the middle of the structure.

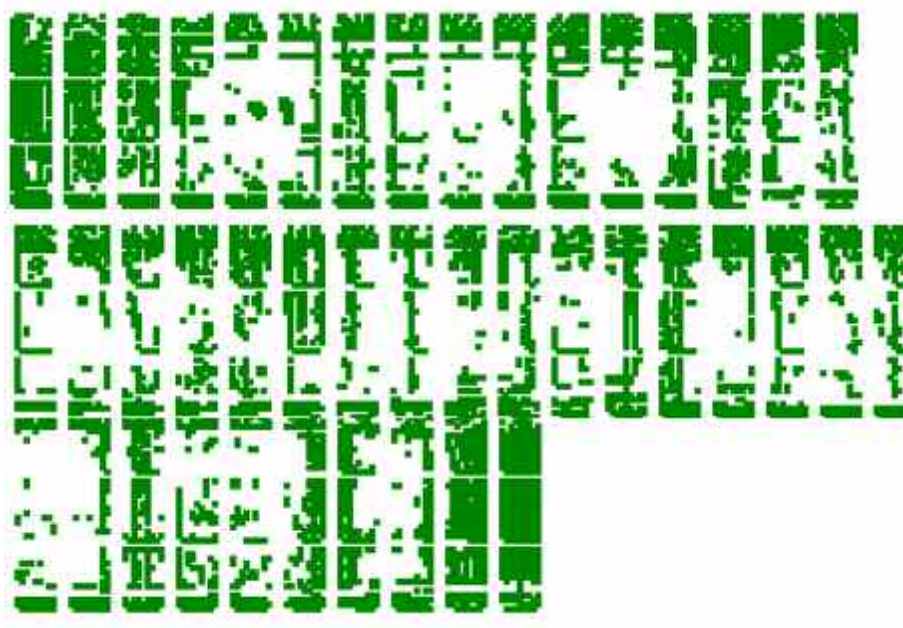
Figure 15: Areas of structure segmented by wavelet-based segmentation method – west internal abutment of Winnersh bridge.

Figure 15 shows the parts of the structure which the wavelet based method has segmented as containing a feature of potential interest to the engineer. This has reported far more features than the entropy method, and also far more than the reference data shows. However, despite these false positives, the general pattern of the bridge is still discernible, with a lot of defects at either end of the bridge, and the

regularly spaced construction joints being visible. A lot of the damp area in the mid section of the abutment is still not reported.

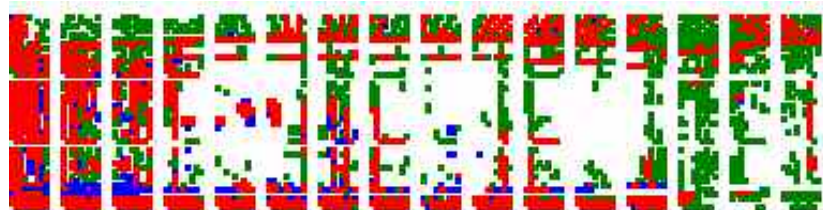
Figure 16: Areas of structure segmented by entropy (blue), wavelet (green) and both (red) segmentation methods – south end of west internal abutment of Winnersh bridge.

Figure 16 shows a section of the abutment where the objects segmented by either or both of the methods are shown. Those objects reported by the entropy method only are shown in blue, objects reported by only the wavelet method are shown in green, and red shows objects which have been segmented and reported by both methods. By combining the methods in this way and only investigating those reported by both methods the incidence of false positives is reduced, and the confidence levels in those that are reported is increased. Figure 17 shows the areas of the western abutment which have been segmented by both methods. The areas of defects at either end of the bridge are clearly visible, as are a number of the construction joints, the lighting cable, and some of the damp patch.

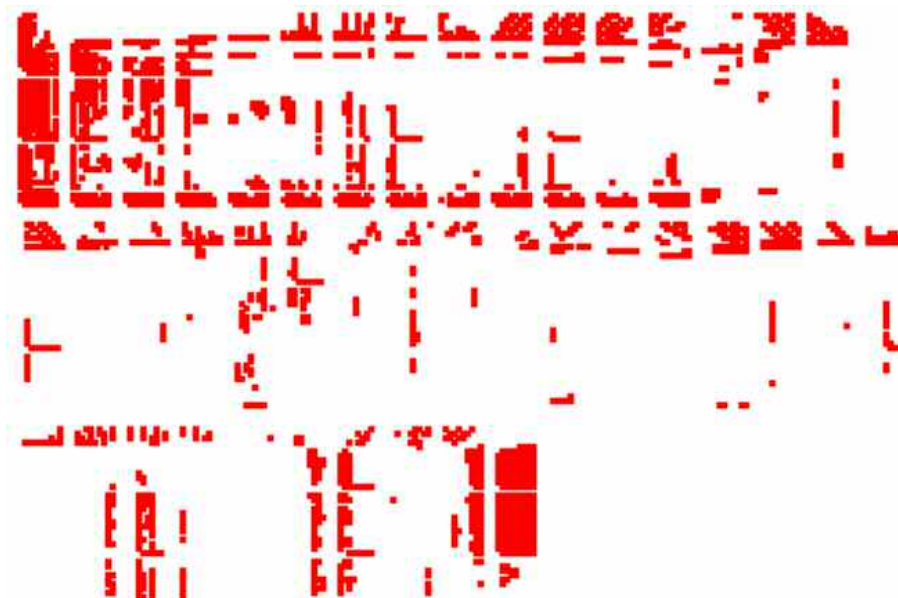
Figure 17: Areas of structure segmented by both segmentation methods – west internal abutment of Winnersh bridge.

Figure 18 shows how well the segmented data presented in Figure 17 compares with the reference data shown in Figure 13. Data from outwith the surface of concern (soffit or pavement have been excluded from this figure). In Figure 18 green parts show correctly segmented features, amber parts show false positives, and red areas show false negatives. These false negatives are of concern as these are areas which may need attention, but which the segmentation is missing. The majority of the false negatives, which are not related to the edge of the structure are from the damp area in the middle of the bridge. A number of defects have been reported here, but the extent of the dampness is very under reported.

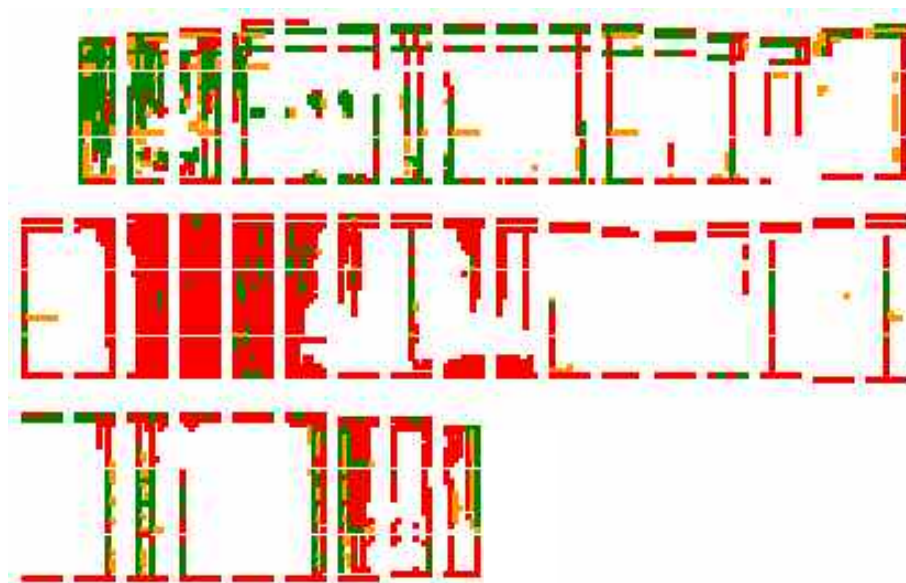
Figure 18: Areas of structure segmented by both segmentation methods – west internal abutment of Winnersh bridge – red = false positive, amber = false negative, green = hit.

A crude numerical assessment of the performance suggests that the segmentation was correct 81.4% of the time, with 4% of the data being false positives, and 14.6% being false negatives.

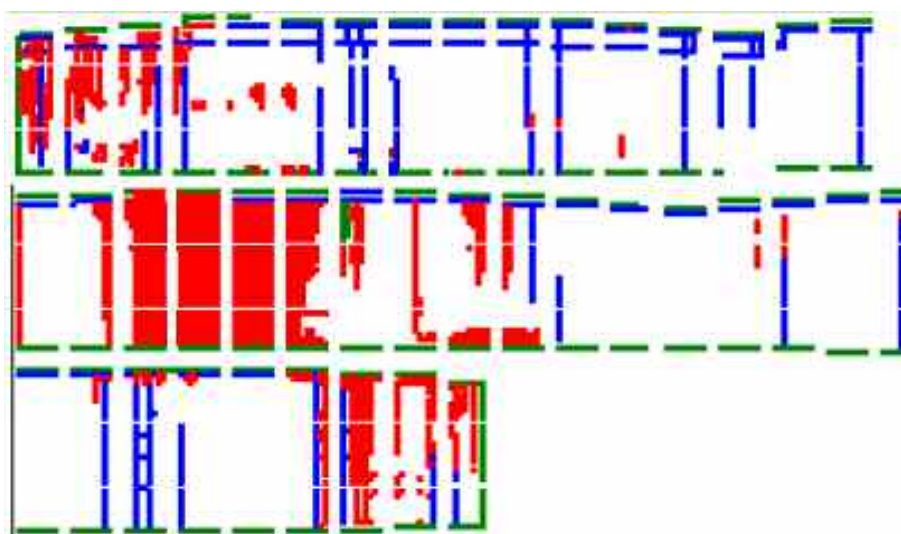
Figure 19: Reference data – west internal abutment of Winnersh bridge

The reference data shown in Figure 19 (the same as that in Figure 13, but reproduced here for convenience) showed the features present in the images as one of three categories – defects, features or 'other'. The segmented objects as reported in Section 5.1.1 have been characterised, and these characteristics used to classify the segmented objects.

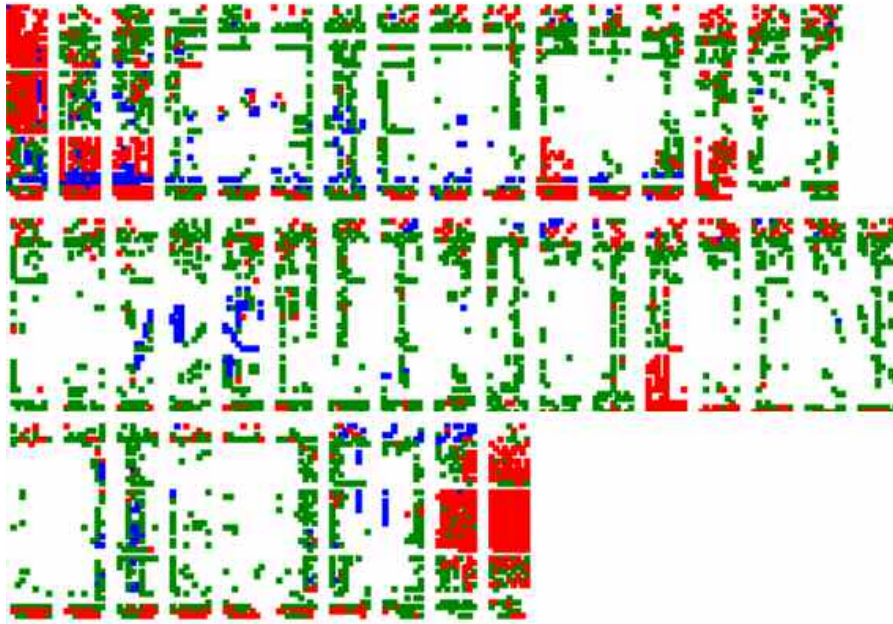
Figure 20: Areas of structure segmented by both segmentation methods and classified – west internal abutment of Winnersh bridge – red = defect, green = feature , blue = 'other'.

Figure 20 shows the results of the classification on the segmented objects shown in Figure 18. In Figure 20 defects are shown in red, features are shown in green, and 'other' are shown in blue.

It can be seen in Figure 20 that the characterisation and classification has been very successful at identifying construction joints and other features which are supposed to be present, and has successfully identified areas of defects at both the north and south ends of the abutment.
