**Characteristics of vehicles producing excessive noise
and ground-borne vibration**

**PPR 246
11108282**

PUBLISHED PROJECT REPORT

Prepared for: Project Record: **Reinvestment project: Investigation of the characteristics of vehicles producing excessive noise and ground borne vibration: 11108282**

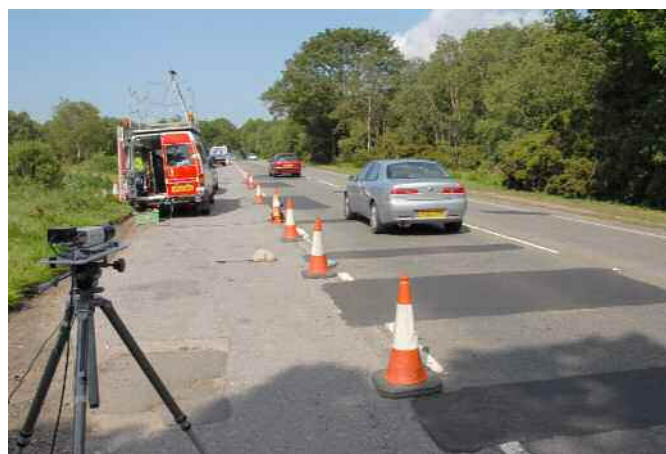
Figure 2.1: View of measurement set-up at Site 1

The cameras can be seen in the foreground and on top of the mobile laboratory (on the left of the photograph). The microphone stand was located just to the left of the nearest camera, but is not shown

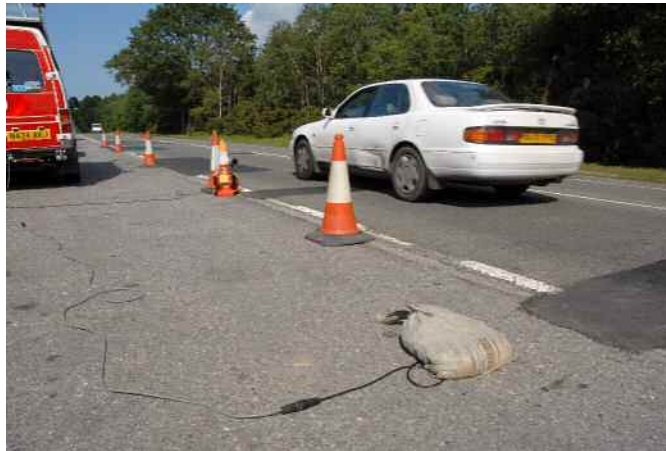
Figure 2.2: PPV transducer placed on the road surface (underneath a sandbag to ensure constant contact with the ground)

in the photograph. A view of the transducer and the irregularity in the road that gave rise to significant ground-borne vibration that could be observed above background levels is shown in Figure 2.2.

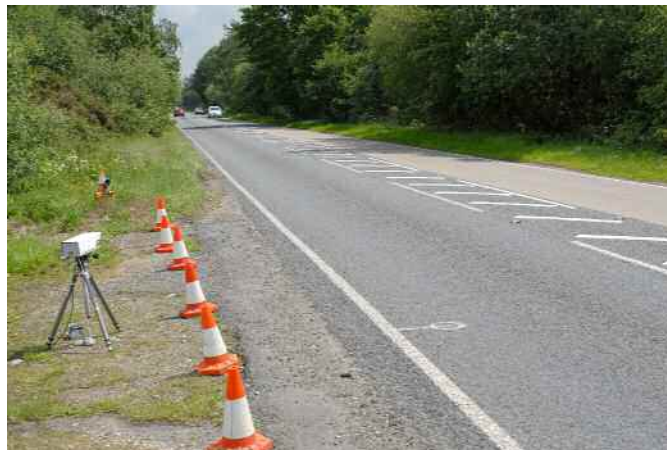
Figure 2.3: View of measurement set-up at Site 2

This was located on the eastbound section of the A30 at Blackbushe Airport. The road surface was a surface dressing, but in better condition than that at Site 1. The layout was similar to Site 1 although the mobile laboratory was located within the grounds of the airport to protect the operators. The site provided an unobstructed view of approaching vehicles, and is shown in Figure 2.3.
