INTELLIGENT MONITORING OF JACK ARCH STRUCTURES: THE RESULTS OF A PRELIMINARY STUDY

Dr J G Kavanagh & Dr K C Brady
TRL Limited
Old Wokingham Road
Crowthorne
Berkshire RG45 6AU
jkavanagh@trl.co.uk

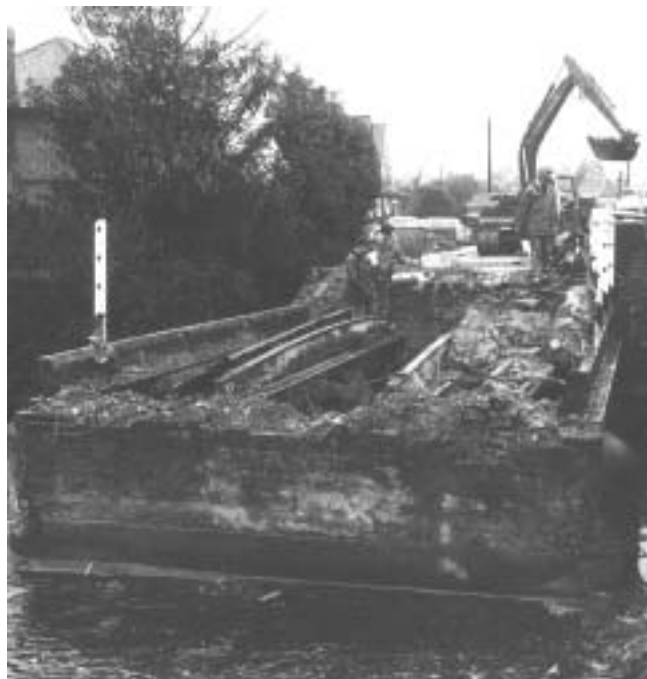
Figure 1 Demolition of the Hythe End bridge, from Daly and Raggett (1991)

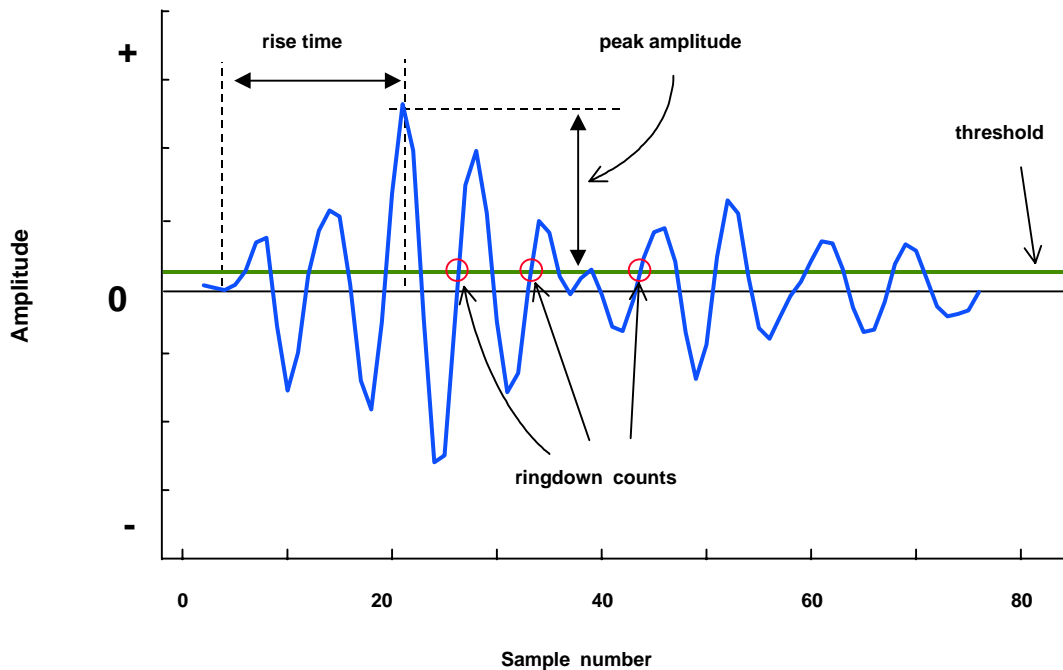
Figure 3 Transducer response to an event and its definition

The AE sensor, a piezoelectric transducer, is attached to the structure under examination. As the structure deforms or deteriorates, an emission is generated by some mechanism (for example, micro-cracking) and propagates through the structure as a series of stress waves. The transducer converts the stress waves (or vibrations) into a voltage. The voltage is processed usually by removing unwanted frequency components (filter) and amplifying the remaining signal. An analogue-to-digital conversion board samples the signal and converts it to a digital format: the data are then stored, usually on disk. An example of the resulting output is given in Figure 3 - this depicts a typical decaying sinusoidal transducer-generated response, termed an 'event'. A number of ways of defining the output are shown on the figure.

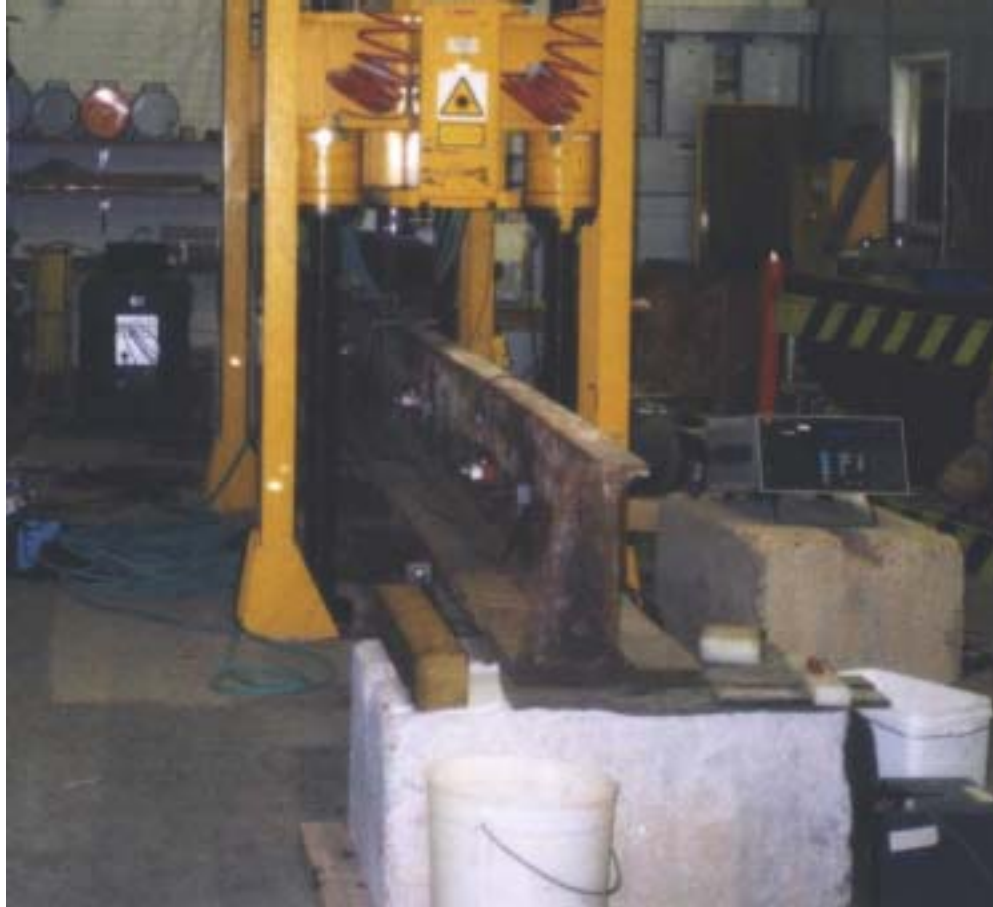
Figure 4 Cast iron beam under test rig

The test set-up is illustrated in Figure 4. The beam was loaded using a computer-controlled 500 kN test rig at the TRL. The computer recorded the movement of the cross head of the rig and the applied load - calculated from the load cells housed in each of the rig supports. As shown in Figure 5, an additional and more accurate load cell, of 450 kN capacity, was placed between the loading platen of the rig and spreader beam.

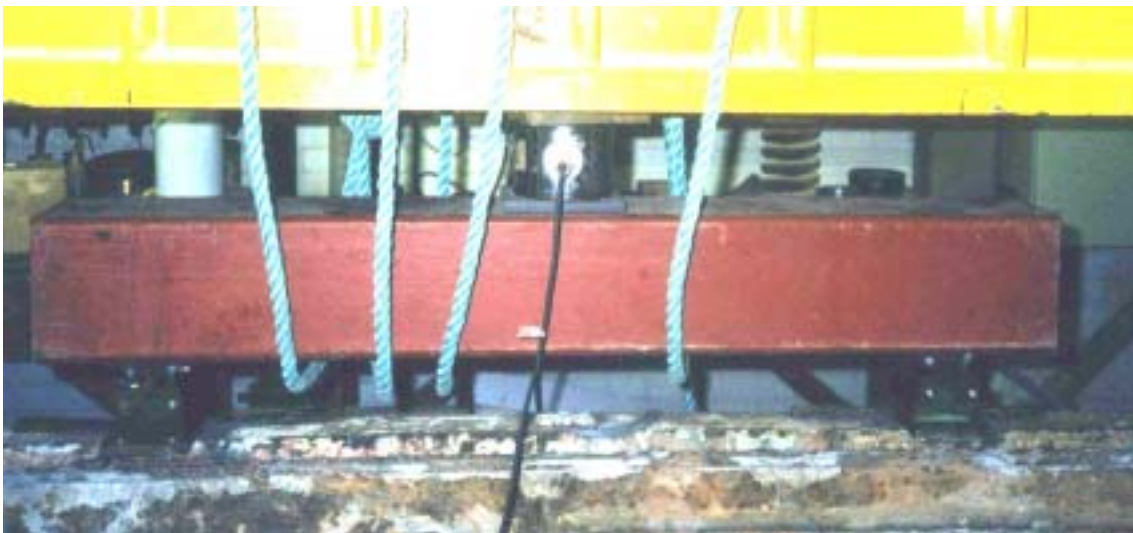
Figure 5 View of load cell and spreader beam

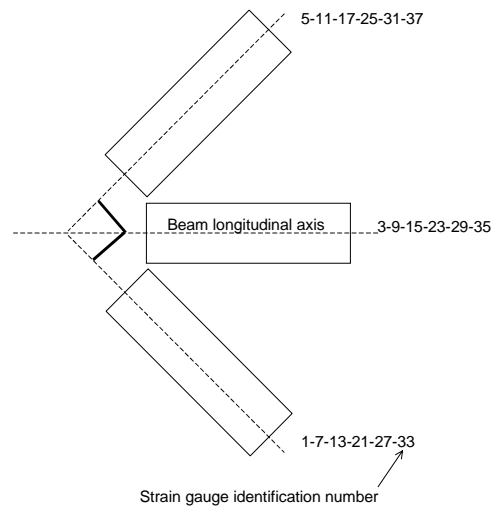
Figure 8 Configuration of strain gauges

The test beam was fitted with six deflection gauges, eighteen strain gauges (in six triplets), five SoundPrint acoustic sensors and four Physical Acoustics (PA) AE transducers. The locations of the instruments are shown schematically in Figures 6 and 7, and the orientation of the strain gauges is shown in Figure 8. The middle set of strain gauges (i.e. 3, 9, 15, 23, 29 and 35) were parallel with the longitudinal axis of the test beam.

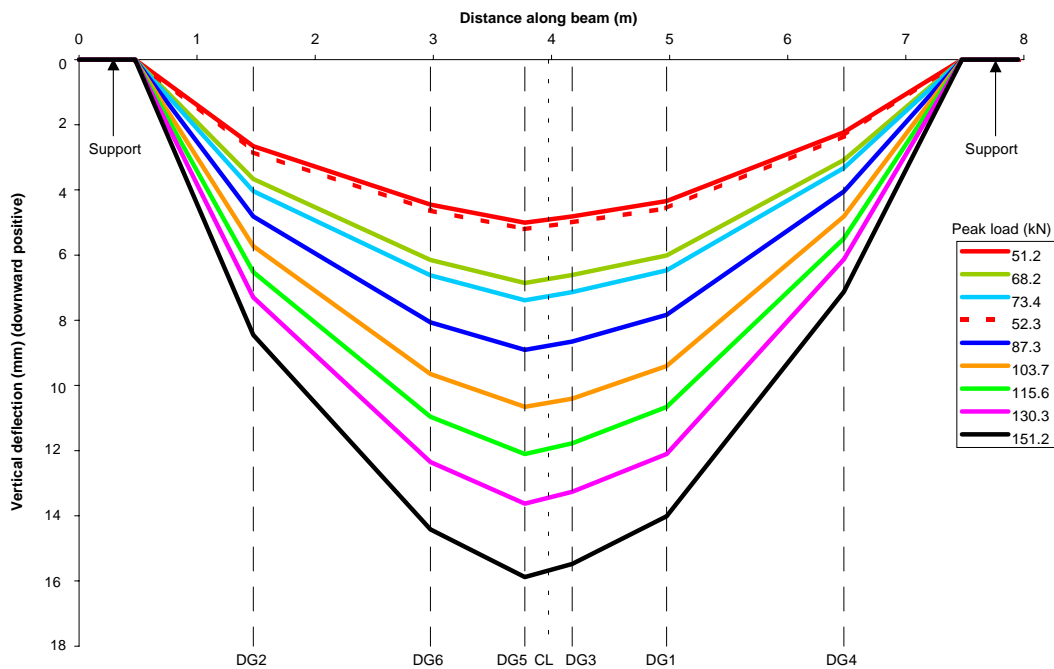
Figure 9 Displacement of beam at peak load for each load cycle

The deflections recorded at the peak loads are plotted in Figure 9: it is evident that the deflection of the beam was slightly asymmetric. As shown in Figure 10, there was a more or less linear relationship between the recorded deflection and the peak load. The deflections plotted in Figures 9 and 10 are those recorded from the start of each cycle of load, but the beam did not return to its original position at the end of each cycle. Although there was some asymmetry in the response, the residual displacement was a little less than 1 mm.

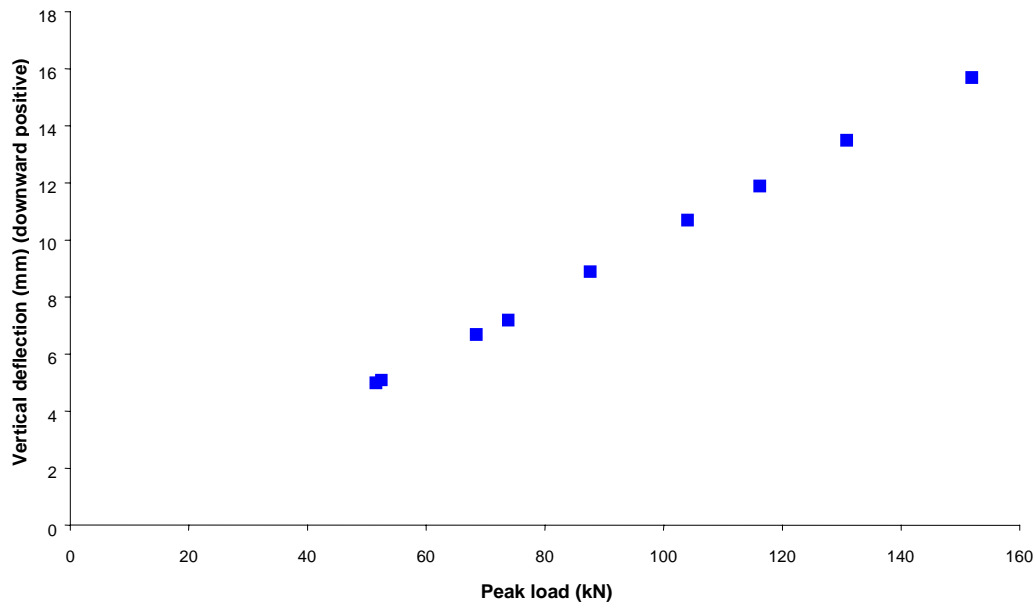
Figure 10 Relation between deflection and peak load

An estimate of the maximum load sustained in-service from measurements of deflection and strain might be based on the premise that there is some noticeable change in stiffness or some permanent deflection as that load is exceeded. But it is quite likely that, in-service, the test beam was within its 'elastic recoverable' range. According to the data from the test, some permanent deflection was noted at an applied load of about 70 kN. Furthermore, there was some small permanent strain induced by the applied load (more noticeably from the third load cycle onwards). A bi-linear relation fitted to the data points in Figure 11, such that the lower line passed through the origin, indicates a (slight) change of slope at a load of about 90 kN. However,

It is improbable that a load-deflection relation, as shown in Figure 10 for example, could be used to predict the collapse load of a jack arch structure. A brittle failure might show as a dramatic, and perhaps unpredictable, discontinuity. A plastic failure would be preceded by an upturn in the relation, but such a change in slope might show that the structure has been weakened (and a load test should not venture into that territory). Such a relation might be extrapolated to determine the (serviceability) load for some limiting and acceptable deflection. For example, according to Figure 10 a limiting deflection of 1/1000 of the clear span of the beam (7 metres) is generated at a load of about 70 kN. It should be appreciated that rarely would such an extended load test be feasible for an in-service structure. Furthermore, the relation for an in-service jack arch structure would be substantially affected by the interaction of the beams, brickwork, and backfill.

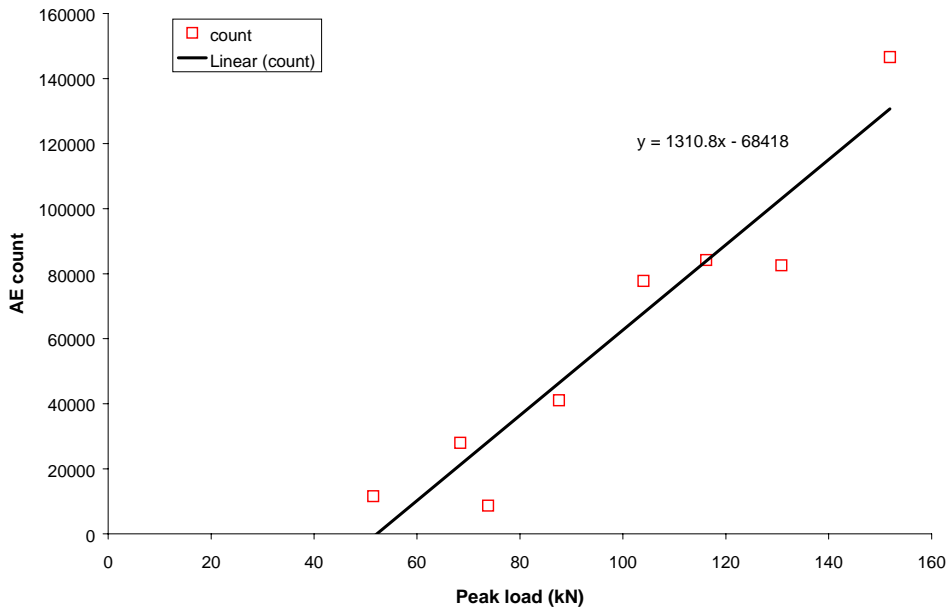
Figure 12 Relation between AE count and peak load

Figure 12 shows a plot of the cumulative AE count on the attainment of the peak load as a function of load. The data point for cycle 4, which was a repeat of the first cycle, has been omitted and a best-fit least squares straight line drawn through the others.

There is little doubt that the AE activity resulted from some load-related mechanism. Given the relation shown in Figure 12, it is probable that AE activity was associated with micro-fracturing of the cast iron beam, perhaps between the graphite flakes and the surrounding matrix. In which case, and as shown in Figure 13, AE activity should reduce as the beam reaches equilibrium with the applied load. Removal of the load would not be expected to generate much AE but some might be generated by the closure of fractures. During reloading, existing fractures would reopen, but this would not generate much activity until the previous maximum load had been exceeded. This model fits the data reasonably well but there are two apparent anomalies that require explanation.

Firstly, as shown in Figure 12, the cumulative AE count recorded at the peak load of about 73 kN in the third load cycle was (at 8,700) substantially lower than recorded (28,000) during the previous cycle where the peak load was 68 kN. It is relevant to note that the rate of AE generated following the attainment of the peak load in load cycle 3 was relatively low compared to the rate generated in other load cycles. Furthermore, the AE activity in the second cycle might have been boosted by the acoustic event recorded by the SoundPrint system (see Table 3). If the number of ‘substantial’ fractures is not a function of the applied load, the relation between AE and peak load will not be smooth. As shown in Table 3, the number of events recorded by the SoundPrint system did not increase uniformly with increasing peak load.

Because of the effect of loading history it might be difficult to determine the peak in-service load from an analysis of the data from the PA AE equipment. Figures 12, 15 and 16 show relations between AE activity and peak load for the various load cycles. A number of the data points could be overlooked in interpreting such relations: nonetheless, extrapolations for various combinations of data points suggest that the maximum previous load sustained by the beam was between about 40 and 50 kN. However, it should be appreciated that,

As shown in Figure 12, AE activity increased, more or less, with increasing load. If activity were related to the size or number of micro-cracks, which could be taken as a measure of damage, it might be possible to extrapolate the load-AE relation to assess the collapse load. Problems inherent in the data obtained from this test include the apparent time-dependency of such relations, and that the number of significant acoustic events did not increase in any definable pattern with the applied load. Furthermore, (a) it is difficult to base predictions of failure on a linear relation and (b) setting the level of AE to represent an 'allowable level of damage' is problematic. Even if a level could be set for this beam, or a range of beams, it would not necessarily be relevant to an in-service structure whose response is affected (perhaps overwhelmingly so) by its interaction with the surrounding backfill and brick arches.

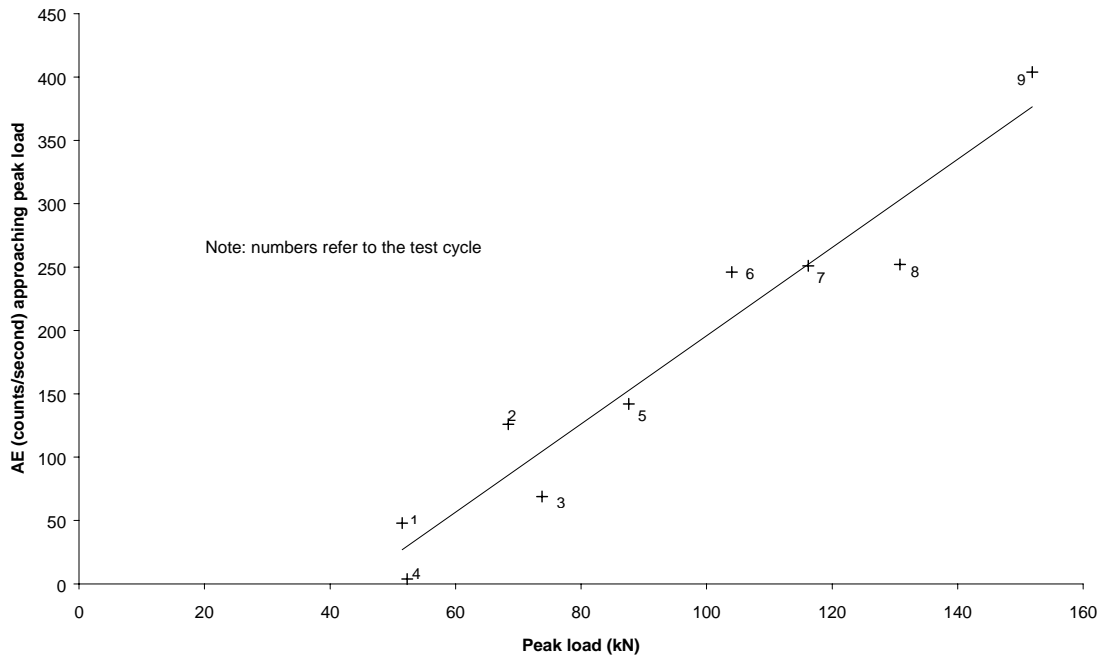
Figure 15 Rate of AE generation approaching peak load for each test cycle

Figure 15 shows the relation between the rate of AE generated as the peak load is approached and the peak load. Note that the data points for load cycle 3, 4 and 8 fall well below the best-fit line: as discussed above, the relation is a function of load history and so could not be expected to be particularly smooth. Figure 16 shows the relation between the rate of AE generated immediately following the attainment of the peak load and the peak load. In contrast to Figure 15, the data points for cycles 1 and 4 fall close together in Figure 16, but the rate for cycle 8 is quite depressed. Note that two data points are shown for load cycle 7: the higher rate corresponds to the attainment of the peak load whilst the lower corresponds to the end of the loading cycle. The rates differ by an order of magnitude, thus again showing the time-dependency of the relation. Further tests are required to characterise the shape of the AE-load relations over much longer loading times.
