Characteristics of vehicles producing excessive noise and ground-borne vibration – Phase 1

PUBLISHED PROJECT REPORT PPR 202

CHARACTERISTICS OF VEHICLES PRODUCING EXCESSIVE NOISE AND GROUND BORNE VIBRATION – PHASE 1

Prepared for: Project Record: **Reinvestment project: Investigation of the characteristics of vehicles producing excessive noise and ground borne vibration: 11108282**

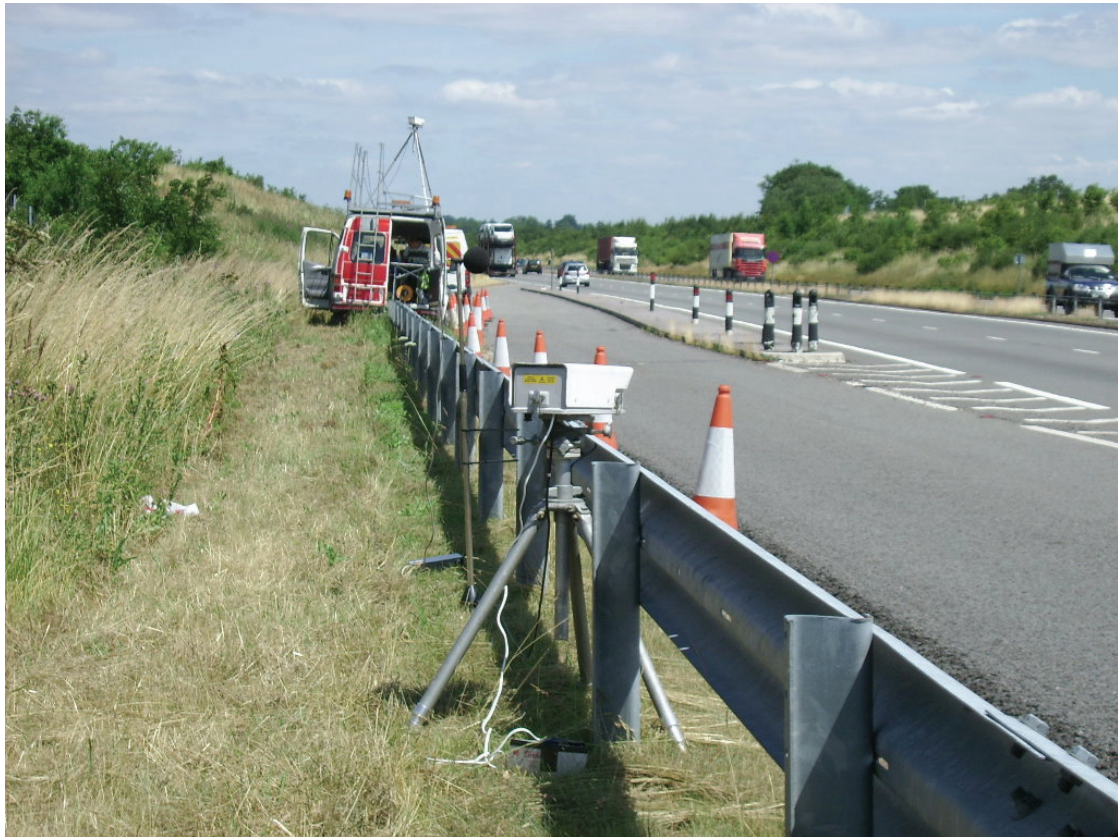
Figure 2.1: View of measurement set up at Site 1

Sites were found alongside busy roads where there was a lay by separated from the main carriageway by an island. This type of site layout enabled the study team to work in a safe location but also in close proximity and with an unobstructed view of the main traffic stream. The first site (Site 1) was on the northbound section of the Newbury by-pass just south of the junction with the A4. The surface was in good condition (porous asphalt wearing coarse) and the open nature of the site allowed freely moving vehicles to be selected from the traffic stream. In this way it was expected to reduce the influence on recorded noise of other vehicles travelling on the carriageway. A view of the site is given in Figure 2.1. The cameras can be seen in the foreground and on top of the mobile laboratory. The

microphone stand is just beyond the nearest camera and appears just to the right of the mobile laboratory.

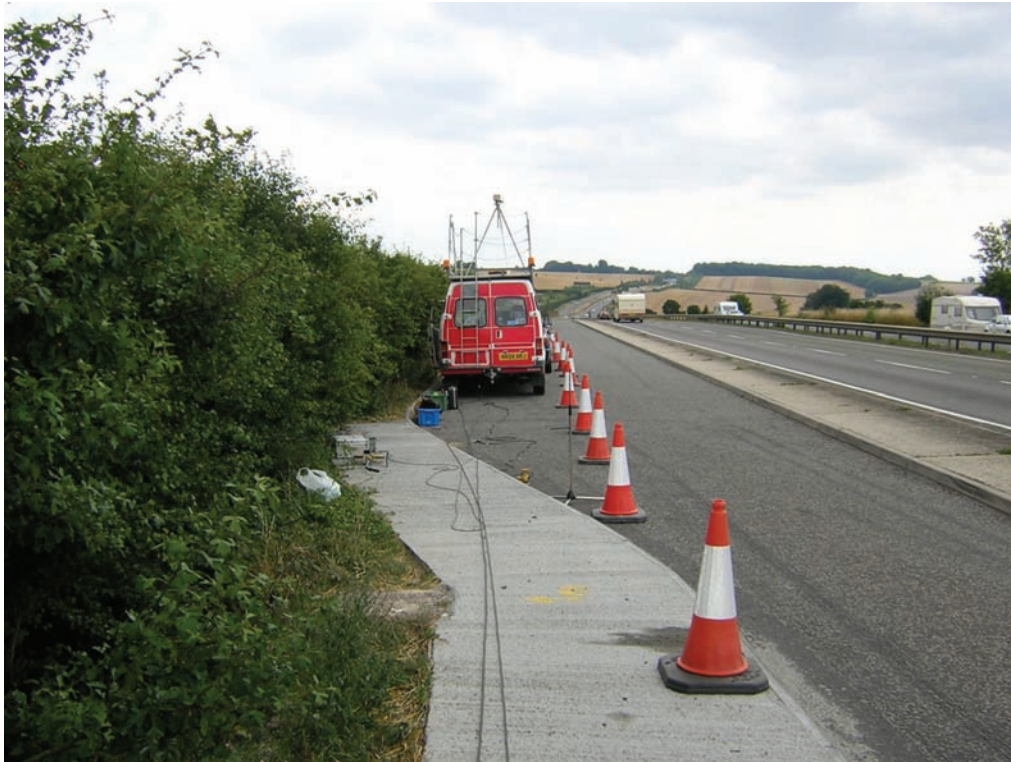
Figure 2.2: View of measurement set up at Site 2

Site 2 was on the southbound section of the A34 near Whitchurch. The layout was similar to Site 1 with an island protecting the operators and an unobstructed view of approaching vehicles. The wearing course of the road surface was hot rolled asphalt (HRA). At this site there was a significant crack across the carriageway opposite the measurement point. It was considered this was sufficient to excite significant ground borne vibration and body rattle noise. A view of the site is given in Figure 2.2. The microphone stand and geophone can be seen in front of the mobile laboratory

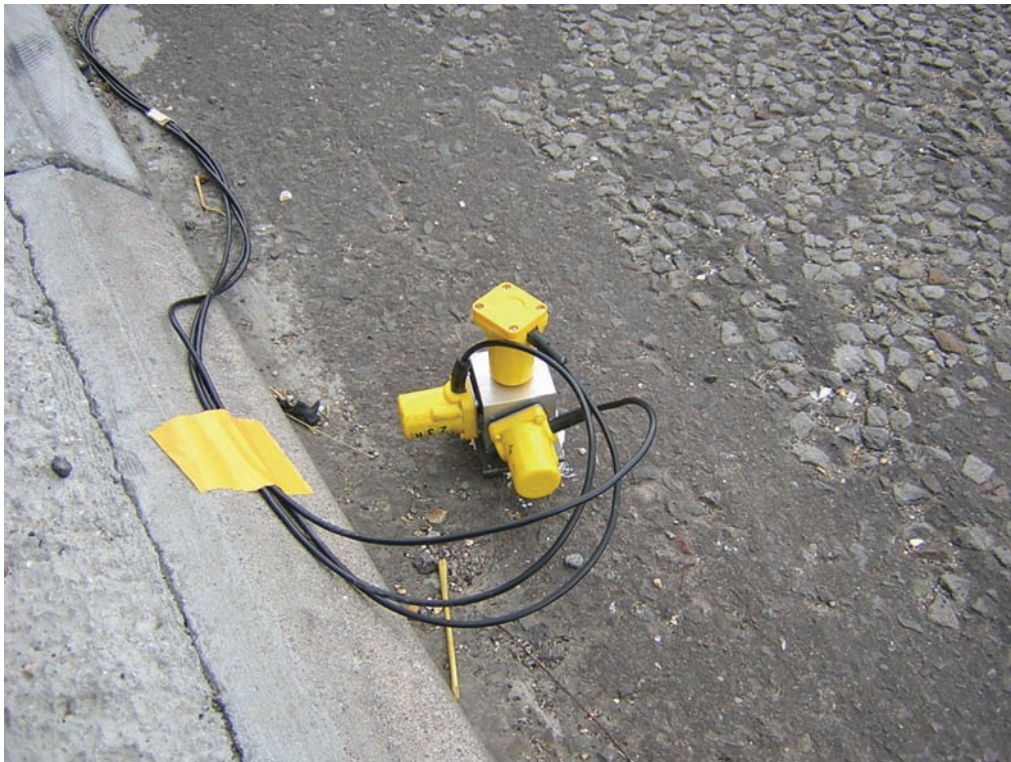
Figure 2.3: Geophone array mounted on the road surface with Plaster of Paris

In addition, at Site 2 the maximum vertical and horizontal particle velocity in mm/s (a measure of vibration amplitude) was obtained from a geophone attached to the road surface at a distance of 8 m from the centre of the lane containing the irregularity. A view of the geophone array is given in Figure 2.3. Figure 2.4 shows the irregularity in the road that gave rise to significant ground-borne vibration that could be observed above background levels.
