# **Automated inspection of highway structures – Stage 2**

**Published Project Report  
PPR255**

**Prepared for: Project Record:      Automatic Inspection of Highway Structures**  
**Client:                                      Transport Research Foundation**  
**(Dr R Kimber)**

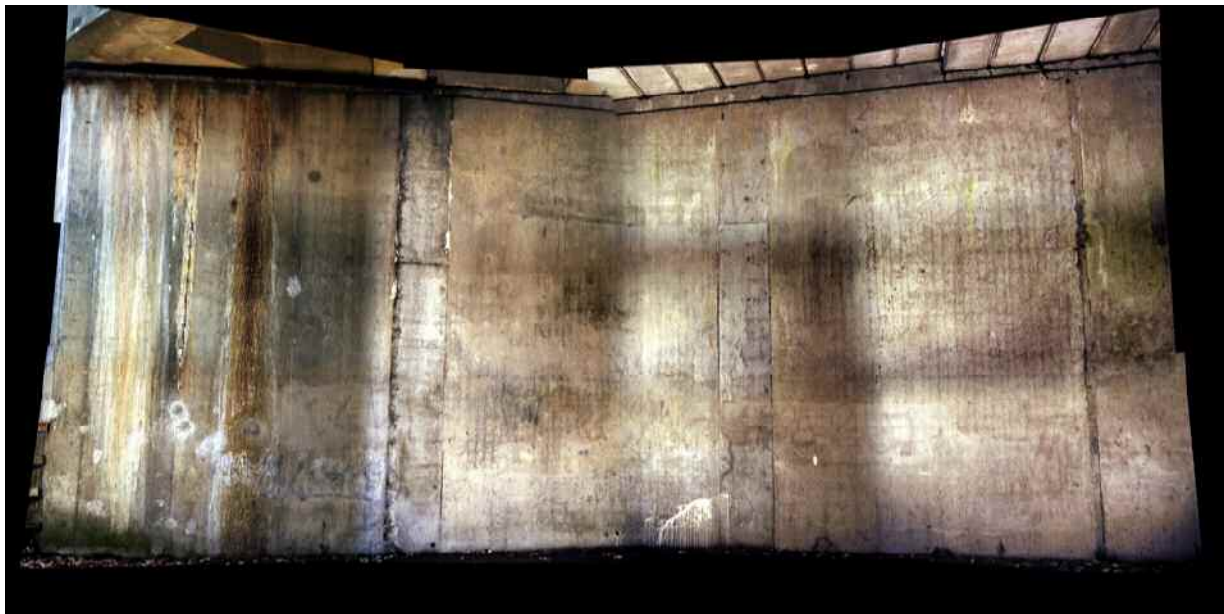
Figure 3 shows the result of using twelve of the images of the bridge wall (6 from each of two locations) to create a single stitched image. This was achieved using commercially available software but took more than three hours of manual intervention to assist the software in identifying the corresponding points on adjacent images, so that the software could warp the images to align them before stitching them together. Inspection of the resulting image shows that images taken from the same location (i.e. the 6 that form the left side or 6 on the right) provide a reasonable image. In maintaining the same camera location (but twisting and tilting for each image) the same viewpoint is maintained, and hence perspective and parallax in each image are similar, making it easier for the software to the images together. However, moving the camera location means that the effects of parallax and perspective play a significant part in the image make up, making it impossible to stitch the images. This is clearly demonstrated through observation of the joints present in the soffit.

**Figure 3: Single image from twelve overlapping images taken from two positions**

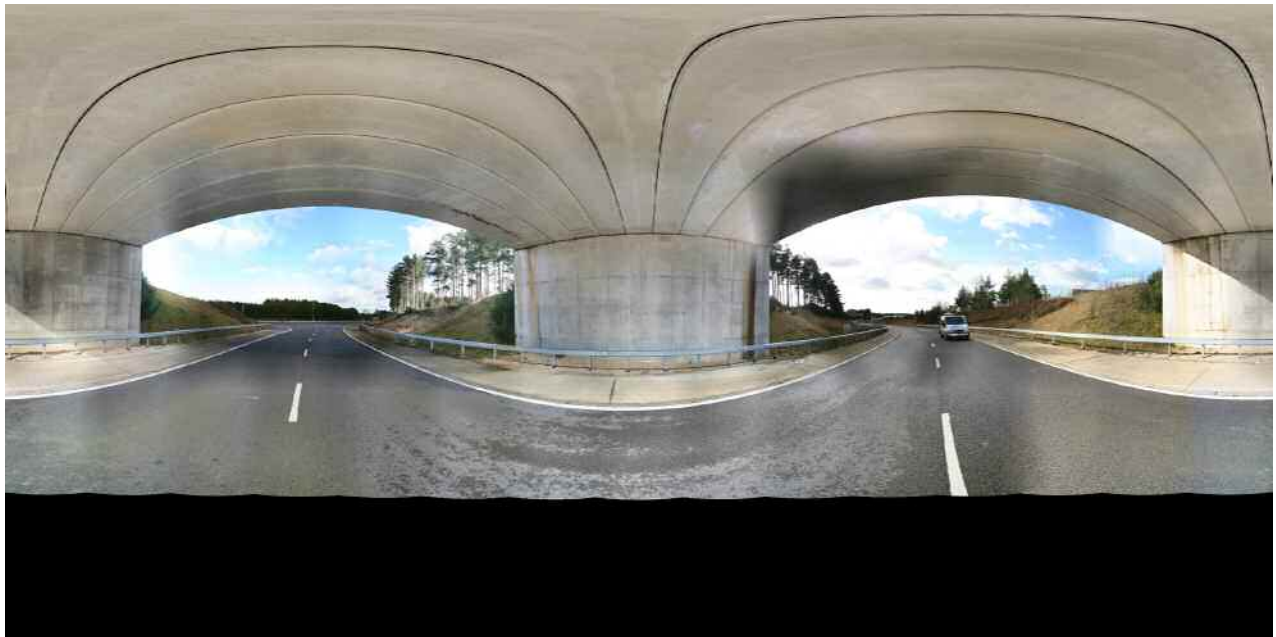
**Figure 5: A Spherical image viewed as a normal photograph**

The image in Figure 5 was created from 59 photographs, each taken from a single location underneath the centre of the bridge with the camera progressively rotated horizontally through 360° and vertically through 180° about the nodal point. The photographs of the ground below the camera were excluded from the image - this is the cause of the black area at the base of the image. However, this area needs to be included in the image because the software that is used to view the image as a sphere assumes that the image covers the full lateral and vertical rotation about the nodal point.

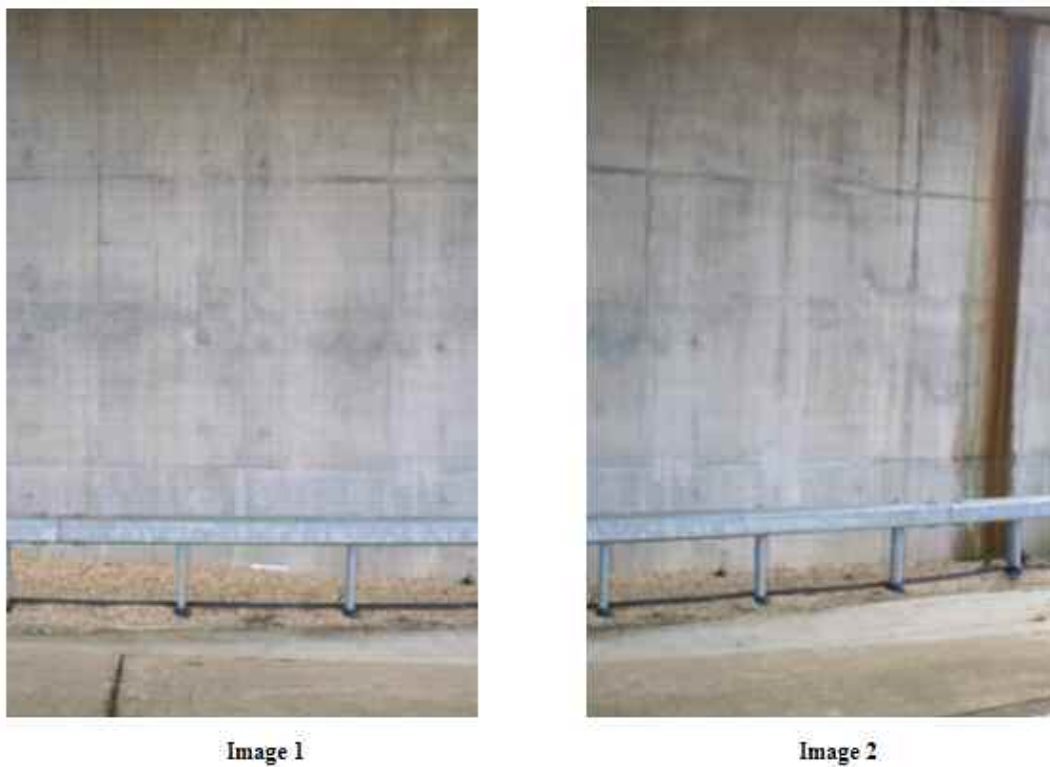
With the knowledge that Image 1 and Image 2 share a common “node point”, both have a horizontal field of view of 29.6° and the relative pan and tilt between the two images is 20° and 0° respectively, we can re-project Image 2 onto the same image plane as Image 1 and produce a re-projected Image 2. Software was developed in Stage 2 to calculate re-projected images. The output from this software when applied to the images of Figure 6 is shown in Figure 7.

**Figure 6: Overlapping images from the same viewpoint – Image 2 shows perspective**

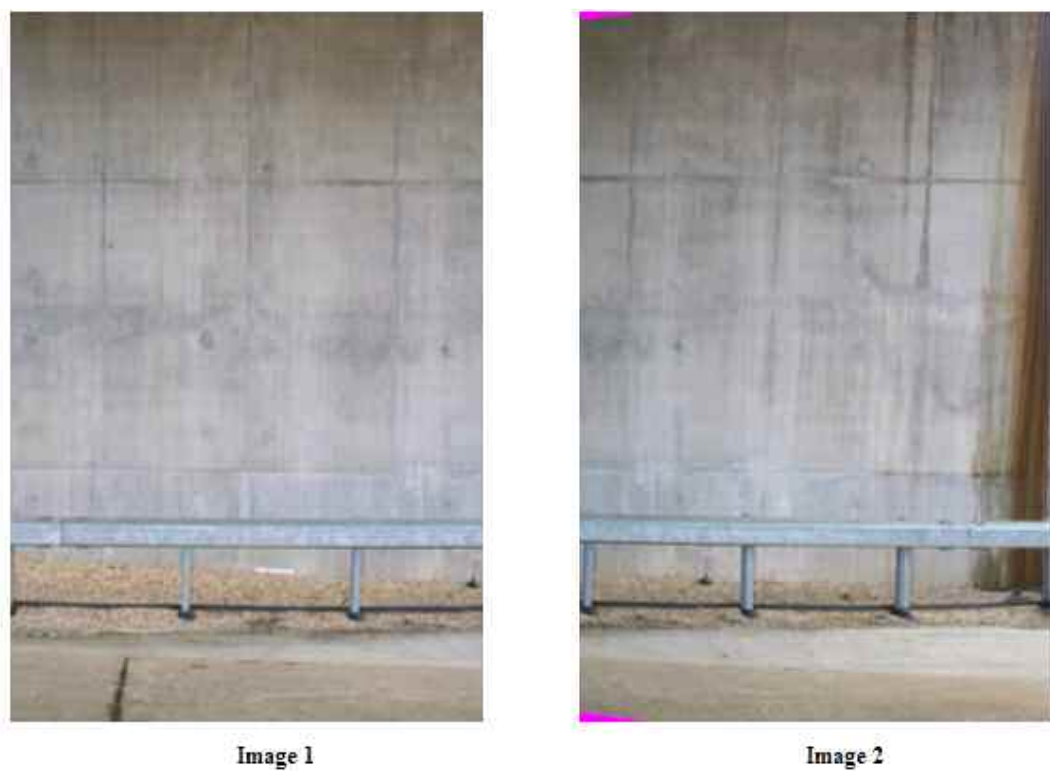
**Figure 7: Same images as in Figure 6, but with Image 2 now re-projected onto same plane as Image 1**

The result of the re-projection process is that spherical aberrations are removed, delivering images that all appear to lie on the same plane. This is an ideal approach for structures, which tend to contain planes relating the individual components (e.g. the soffits). By re-projecting all the images from a

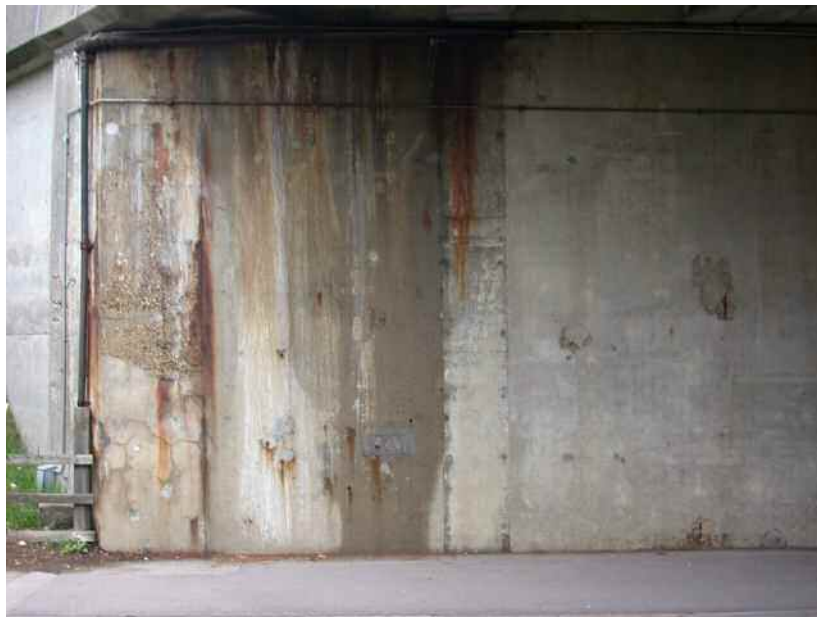
**Figure 8: Structure at Winnersh (M4 over B3030).**

The bridge shown in Figure 8 (maps showing bridge location are shown in Figure 9) was selected, inspected and photographed to enable comparisons to be made between the condition of the bridge as determined on site, and the condition determined by viewing the images. Images were collected using a 6 mega pixel digital camera, mounted on a tripod, using the Stage 1 approach described in Section 2.3. Each image covered an area of bridge approximately 2m high by 3m wide, meaning that each pixel was approximately 1mm square. The external walls of the structure were photographed, using the same camera mounted on a tripod, from a single point on the side of the road, approximately 10m away from the structure. During image collection the location of each image relative to the face being imaged was recorded (e.g. x,y position relative to the left bottom point on the face). This enabled the images to be collected together for display and manual analysis.

The development of automated techniques utilised images from the structure at Winnersh (used in the manual assessment of images and shown in Figure 8 and Figure 9), and two additional bridges. These bridges were located in Eton Wick (Figure 16 and Figure 17), and between Frilsham and Hampstead Norreys (Figure 18 and Figure 19).

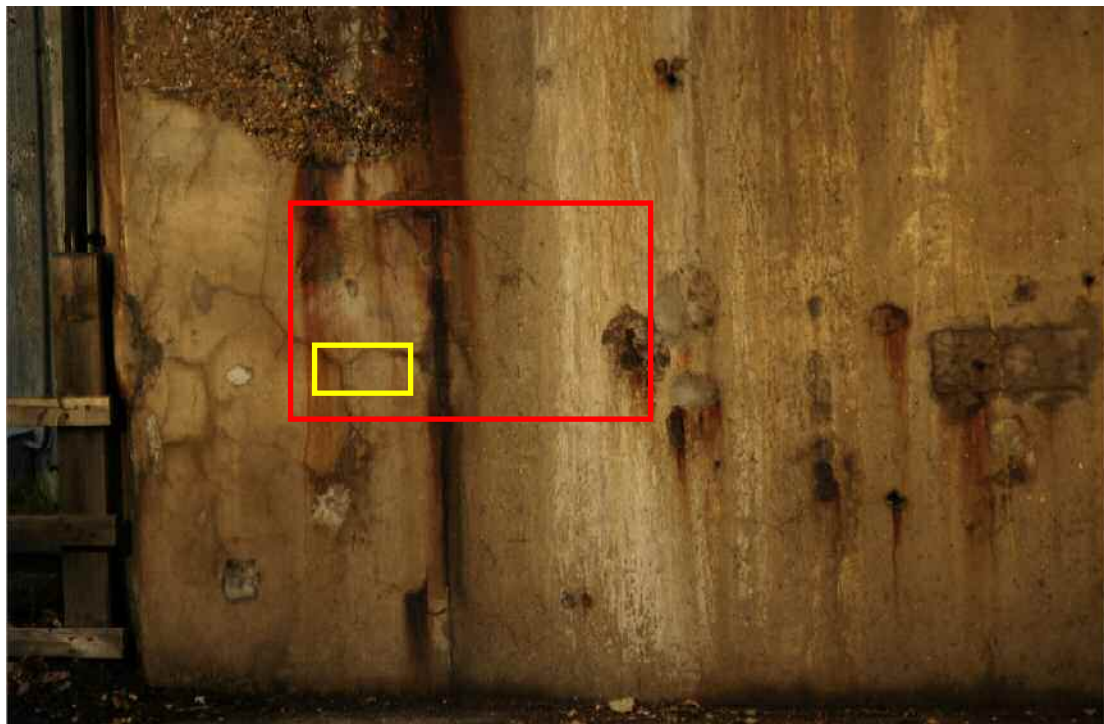
Figure 10: Full image of part of west internal wall

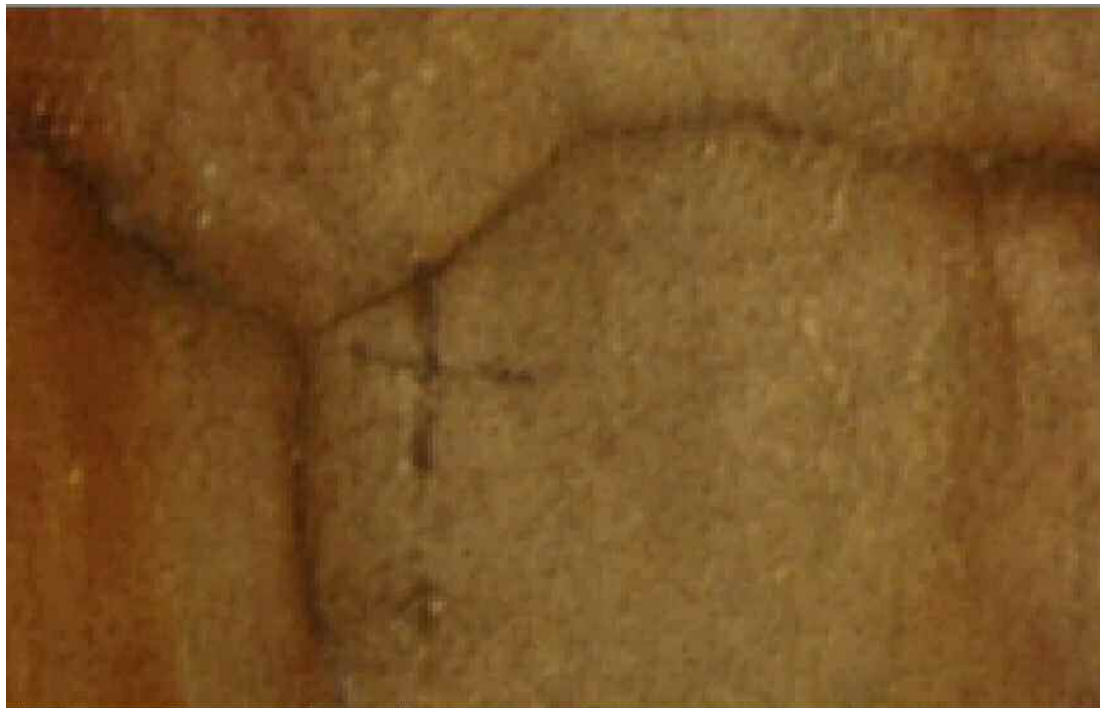
**Figure 12: Zoomed in image of region highlighted in yellow in Figure 10 and Figure 11, showing maximum level of detail achievable without distortion.**

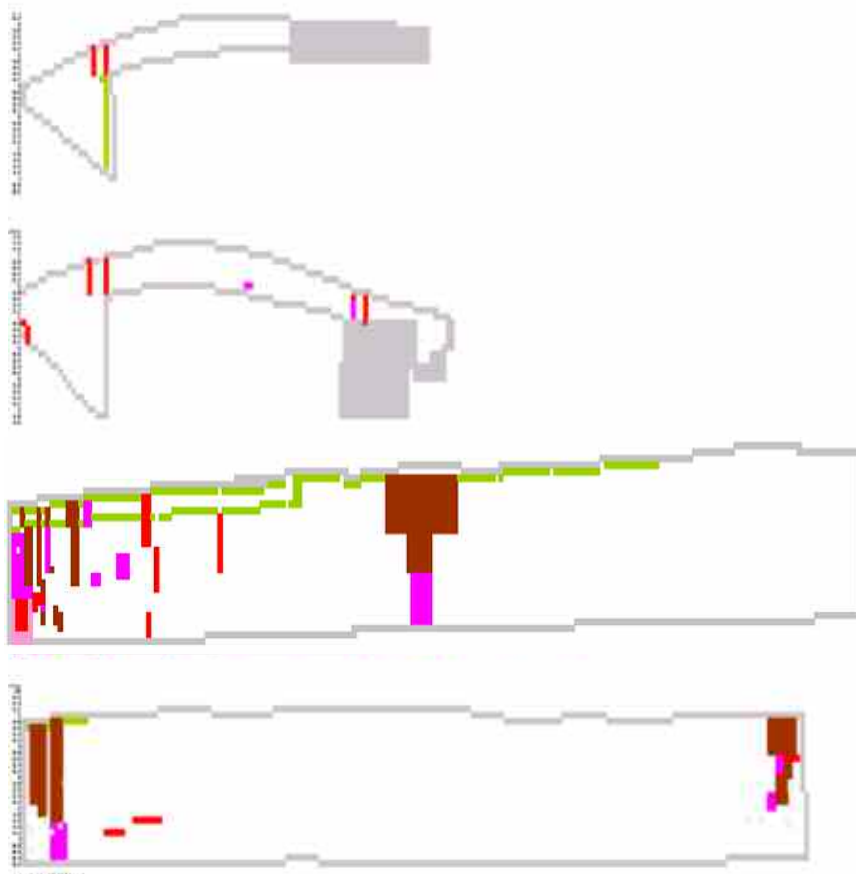
Figure 14 shows the results of the onsite inspection after being converted into a defect map. The grey lines show the outline of the structure being surveyed (this outline has been directly copied from the image based assessment so as to enable a like-for-like comparison), and any obscured areas of structure. Green lines correspond to features which were recorded in the inspection, but which do not relate to defects (e.g. cables). Other features, such as cracking, spalling or rust are shown in redder tones.

**Figure 14: Results of onsite inspection translated into a defect map (top to bottom – north external wall, south external wall, west internal wall, east internal wall). For key see text.**

Comparison of Figure 14 and Figure 15 shows that the manual inspection of the images generally identified the areas of the structure which were affected by defects, and it therefore follows that this inspection generally identified those parts of the structure where no defects were present.

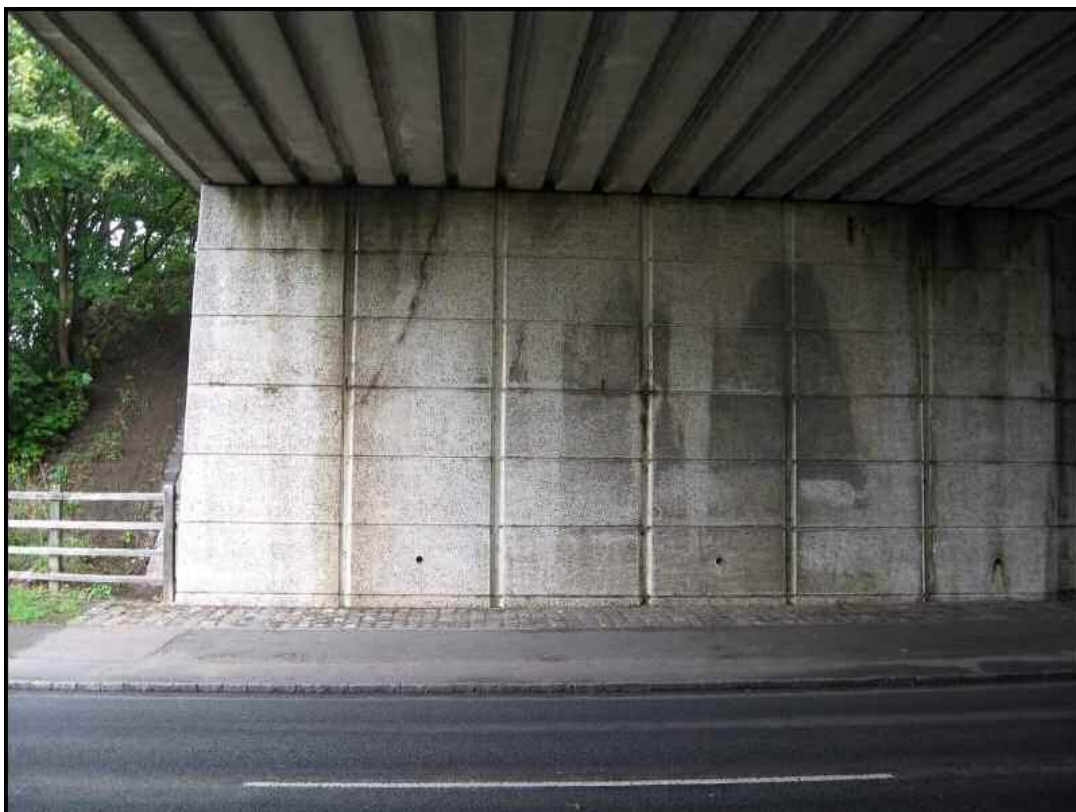
**Figure 17: Eton Wick site. A332 over B3022.**

Although these additional structures were constructed from concrete, similarly to the structure at Winnersh, these bridges differed in a number of areas. In particular, the Eton Wick structure has a grid like appearance on the supporting walls (Figure 17) and has a surface containing larger aggregate sizes visible on the surface, giving it a more roughly textured appearance than the other two smoother bridges.

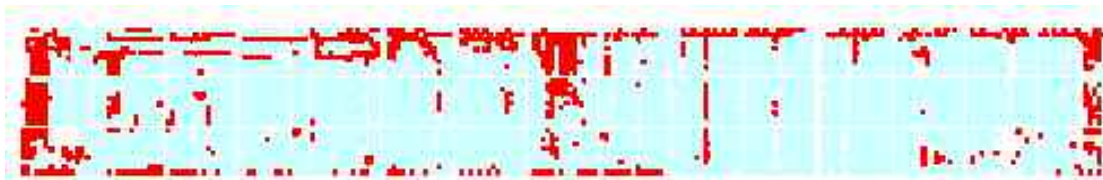
Figure 30 shows another display of the initial segmentation and the discriminant, but this time the initial segmentation has been used to rule out parts of the bridge which do not contain anything of interest. In this display light blue shows those parts of the bridge which did not generate any response from either of the initial segmentation methods, which are now assumed to not contain anything of interest. Red areas now show the areas of the structure which were classed as containing something of interest by the discriminant function, and were not ruled out by the initial segmentation.

**Figure 30: Combination of discriminant function results and initial segmentation. (individual images, Winnersh bridge, west face). Blue = zero reported by both initial segmentation methods; Red = classed as a defect / feature by discriminant, and not ruled out by initial segmentation.**

Figure 31 shows the reference data for the structure again (as in Figure 26), for comparison with Figure 30. It can be seen in Figure 30 and Figure 31 that the process of using the initial segmentation to detect areas thought to contain nothing of interest, together with the discriminant function to detect features of interest gives encouraging results, in terms of defects and features. It must be noted however, that the vertical joint features, clear in the reference data, are not detected in the automatic analysis shown in Figure 30.

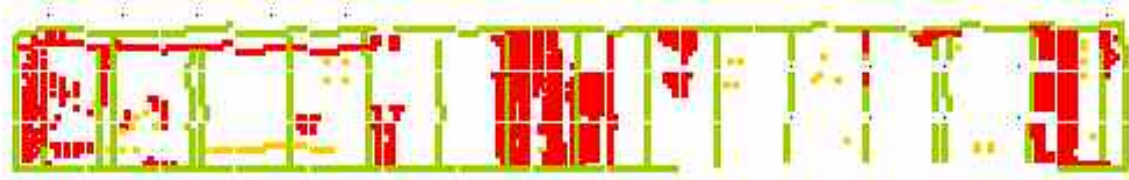
**Figure 31: Manual image analysis reference data (individual images, Winnersh bridge, west face). Red = 'Defects'; Green = 'Features'; Yellow = 'Other'**
